# Compilation of Observations of the October 15, 2006 Kiholo Bay (Mw 6.7) and Mahukona (Mw 6.0) Earthquakes, Hawai'i

December 31, 2006

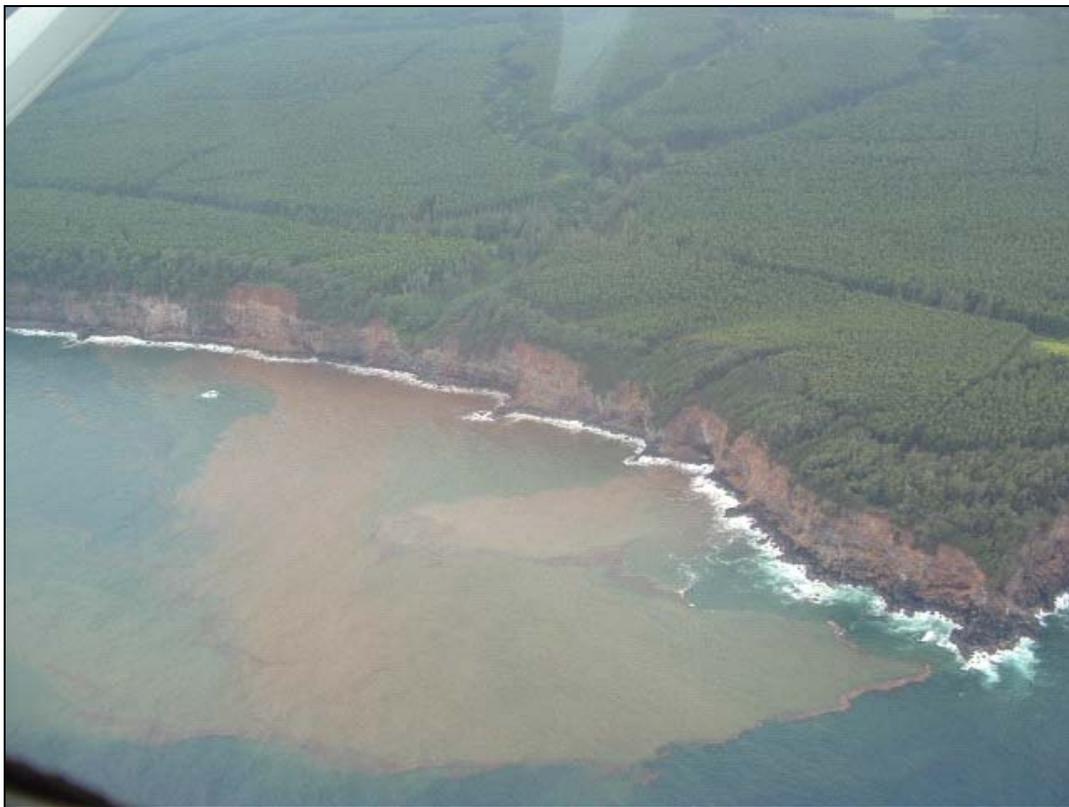
**Figure 8 Massive coastal escarpment landslides into the ocean, Hamakua Coast  
(Photograph courtesy of Hawaii Civil Defense Agency)**

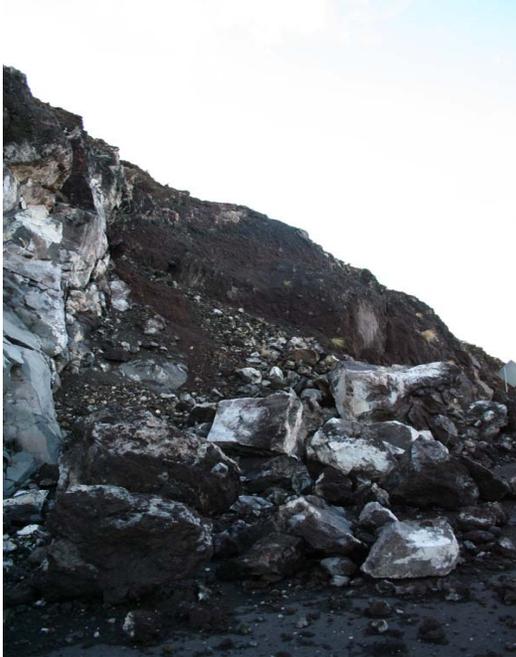
**Figure 9 Rockfall typical at steep roadcuts**

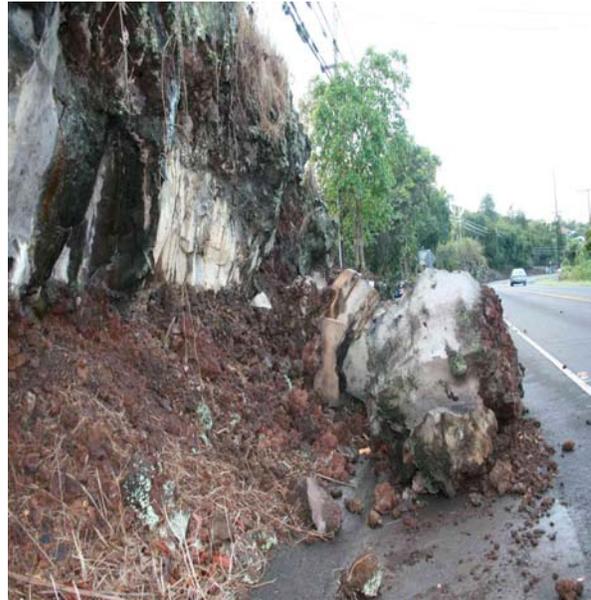
There is a considerable difference in the mechanical properties of the *a'a* clinker and massive basalt. During the earthquakes, the loose *a'a* clinker raveled and removed support from overlying massive blocks. The blocks can sustain significant cantilevers, influenced by the extent, spacing and nature of the internal discontinuities, but many overhanging blocks failed during the earthquakes. In particular, large boulders fell where there was a noticeable layering of volcanic rock strata with dense, blocky basalt overlying more friable pyroclastic tuff, ash and clinker (Figure 10). The underlying weaker layers typically consist of smaller rock units, which are less resistant to shearing and therefore provide minimal stability with respect to lateral loading.

**Figure 10 Example of discontinuous geology where dense basalt rock overlies weaker and less stable clinker**

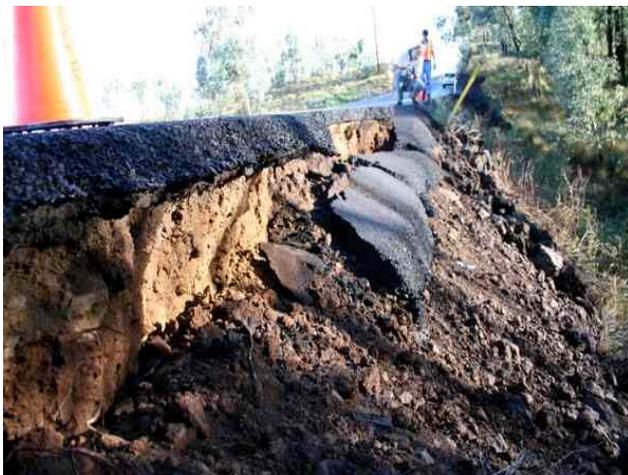
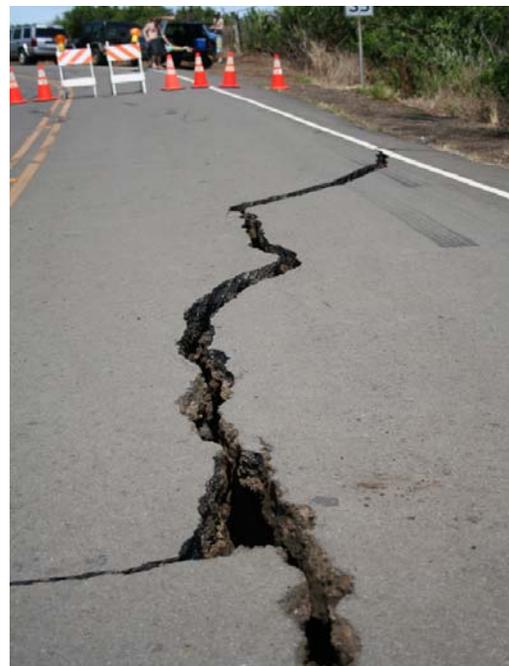
Although rock and soil slides in cuts above roadways were numerous, damage to road embankments and pavements was less prevalent, with a few exceptions (Figure 11). The most dramatic of these was the collapse of half of the roadway at Mile 35 on Highway 19 near Pa'auilo, resulting in the closure of one lane of traffic (Figure 12). This was caused by failure of a 20-foot high embankment and rock wing wall on the approach to a concrete girder bridge. The cast-in-situ concrete girder bridge is supported on rock wall abutments. The bridge suffered no damage but the adjacent embankment failed. The wing wall consisted of mortared rock and was approximately 14 inches thick.

**Figure 11 Highway Embankment and Roadway Failures**

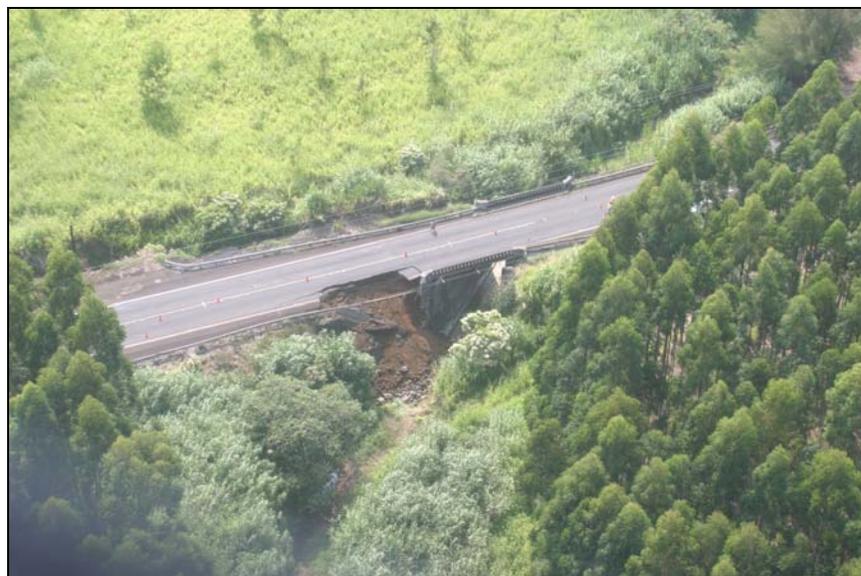
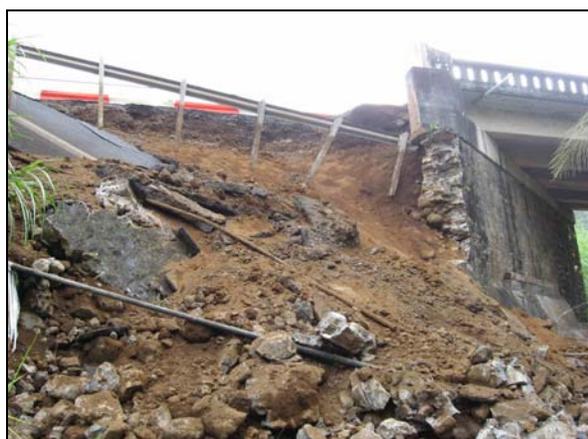
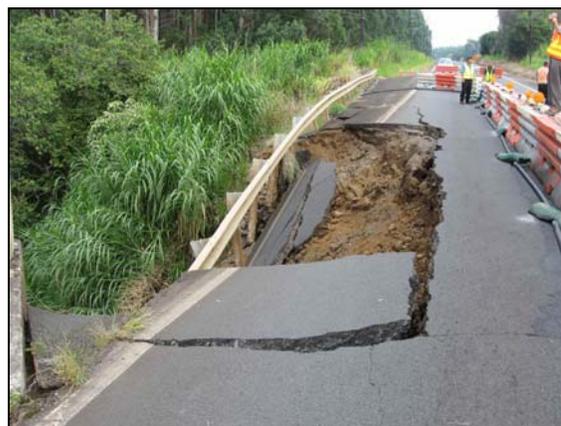
**Figure 12 Failure of Bridge Approach Embankment On Highway 19  
Due to a Retaining Wall Collapse  
(Photographs courtesy of State of Hawaii Dept of Transportation,  
Highways Division, and Hawaii County Civil Defense Agency)**

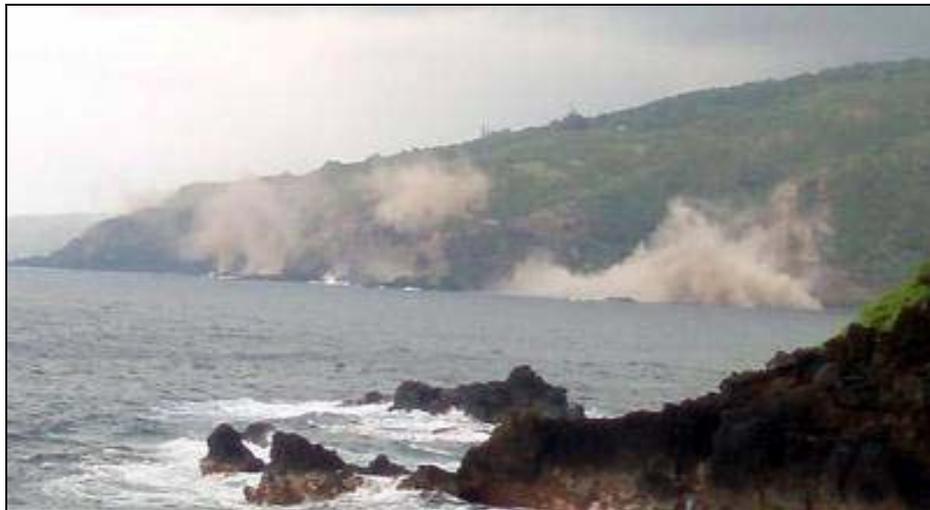
The island of Maui was also impacted by several rockfalls induced by the earthquakes (Figure 13). Highway 31 along the southeastern coast of Maui was closed near Manawainui (Figure 14). Rockfall debris at the Kalepa cliffs impacted the highway (Figure 15). About 500 Maui residents were cut-off between an incipient rockfall hazard of that road in the Manawainui area and a bridge closure due to abutment erosion at Pa'ihi. After an engineering evaluation and fast-track design, the installation of a temporary steel truss bridge was completed at the end of November. Sections of that highway along the coastline are inherently vulnerable to rockfalls and landslides (an example is shown in Figure 16). A few days after the opening of the temporary bridge, new rockfalls at Kalepa closed the highway again. The County of Maui is scaling loosened rocks and boulders from several vulnerable slopes. The discontinuous and often contorted inclusions of massive basalt are irregularly fractured.

**Figure 13 Massive Landslides on the Southeastern Coast of Maui  
During the October 15, 2006 Earthquakes (Kalepa on the right)**

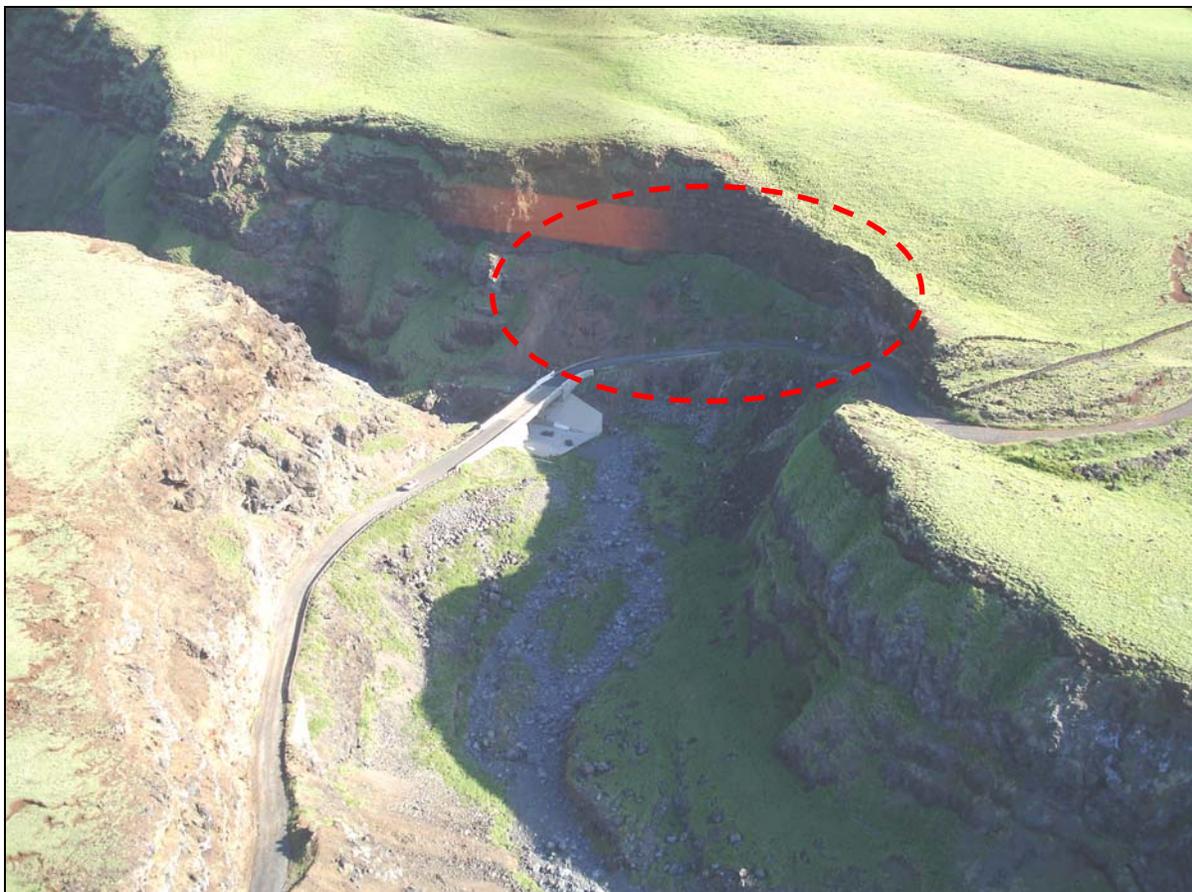
**Figure 14 Manawainui, Maui (incipient rockfall over the roadway indicated on the photograph)  
(Photographs courtesy of Maui Civil Defense Agency)**

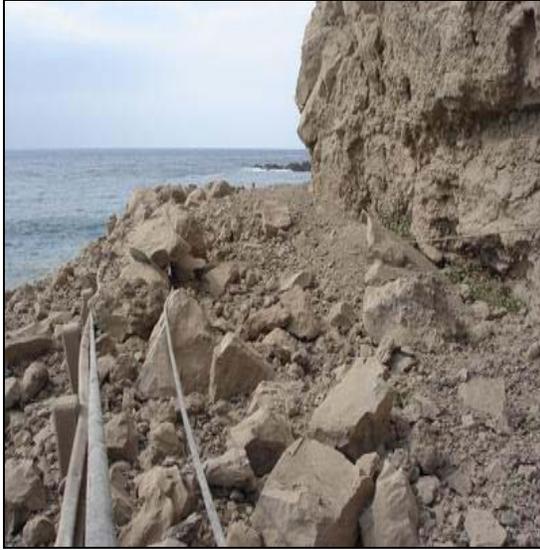
**Figure 15 Maui Rockfall at Kalepa cliffs  
(approx. the 38-mile marker along Hwy 31)**

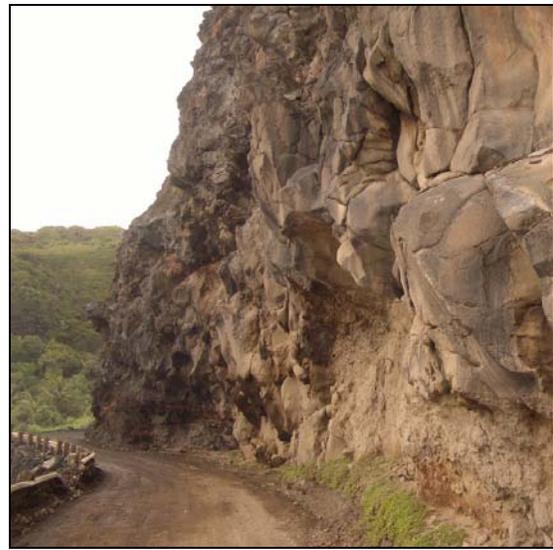
**Figure 16 Example Area of Potential  
Rockfalls along Maui Hwy 31**

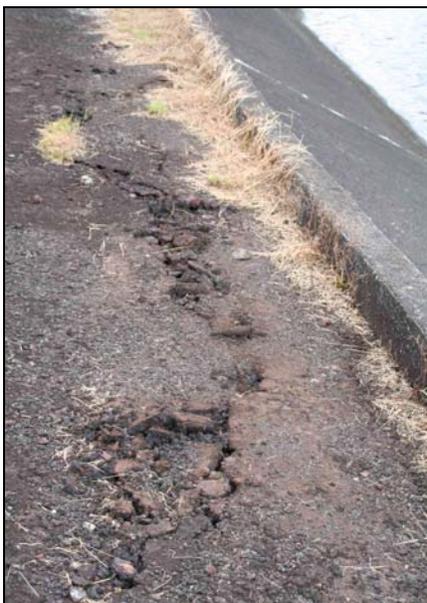
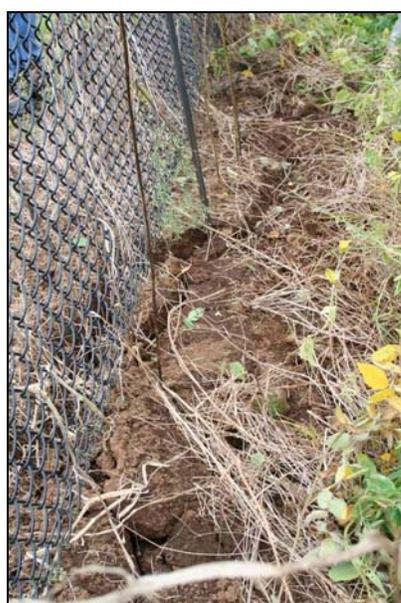
Some damage occurred to dams and irrigation ditches in the Waimea-Kamuela area where recorded peak ground acceleration exceeded 1g (soil depths are greater in that region than along the rocky coast nearest the epicenter). Most dams in Hawai'i are old earthen berm reservoirs built during the plantation era originally for irrigation purposes. At least two dams experienced cracks along their crests, while at least two others showed clear evidence of incipient slope failure on their embankments (Figure 17). The Pacific Disaster Center performed dam break simulations for Hawaii County Civil Defense. Two dams located above Waimea were drained after excessive seepage and "water boils" were observed five days following the earthquakes. The State Department of Land and Natural Resources had in place post-earthquake dam inspection procedures. The Hawaii Dam Safety Guidelines: Seismic Analysis & Post-Earthquake Inspections (Brandes, 2004) call for inspections of dams within 75 miles of the source of an earthquake of magnitude between 6 and 7. The U.S. Army Corps of Engineers was undertaking these comprehensive inspections.

**Figure 17 Cracking and  
stability failures on the  
crest of reservoir dams**

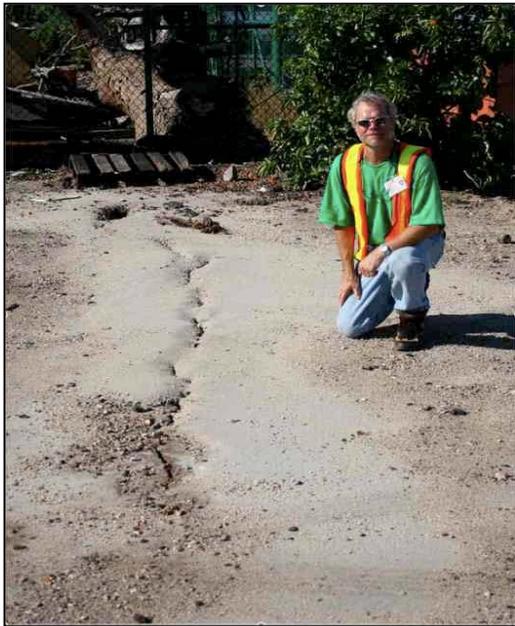
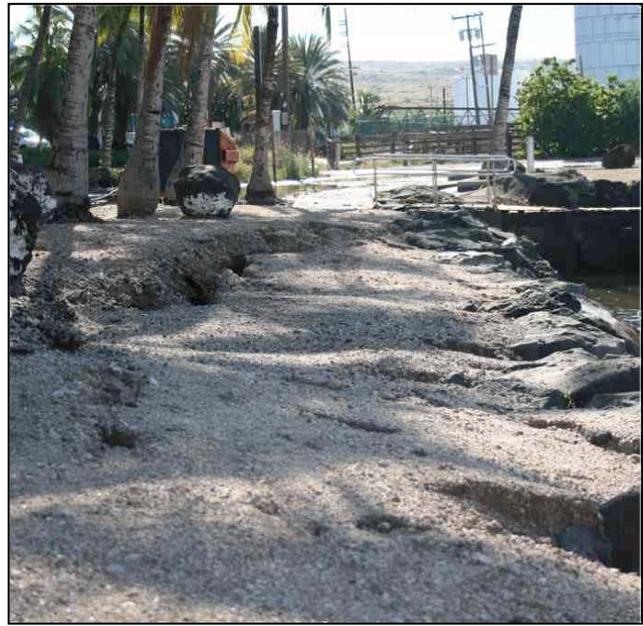
Kawaihae Harbor sustained major damage from liquefaction and lateral spreading. Sand boils were observed throughout the harbor area (Figure 19). Much of the fill material under the shipping container handling yard consists of dredged fill. As this material liquefied, the resulting lateral spreading caused significant vertical settlement of the asphalt pavement, and lateral displacement of the pile supported concrete piers. Large areas of the asphalt yard, had settled up to approximately 6 inches (Figure 20). Fine sand had been ejected from cracks in the asphalt pavement and through junctures between the paved fill area and the pile-supported concrete pier. A series of cracks with widths ranging from approximately 1/4 inch to several inches were observed roughly aligned parallel with the shoreline. Cumulatively, these cracks displayed lateral spreading of 6 inches or more. Personnel at the facility described fine sand and water “squirting out of the cracks” in the pavement immediately following the earthquakes. Pier 1 displaced as much as 6 to 12 inches laterally towards the harbor. This movement indicates that the piles were moved and/or distressed by the lateral spreading of the liquefied soil beneath and landward of the pier. It is unknown at the time of writing this report if any damage had been incurred by the piles supporting this pier.

Figure 19 Examples of sand boils and lateral spreading, Kawaihae Harbor  
(Photographs courtesy of Peter Nicholson)

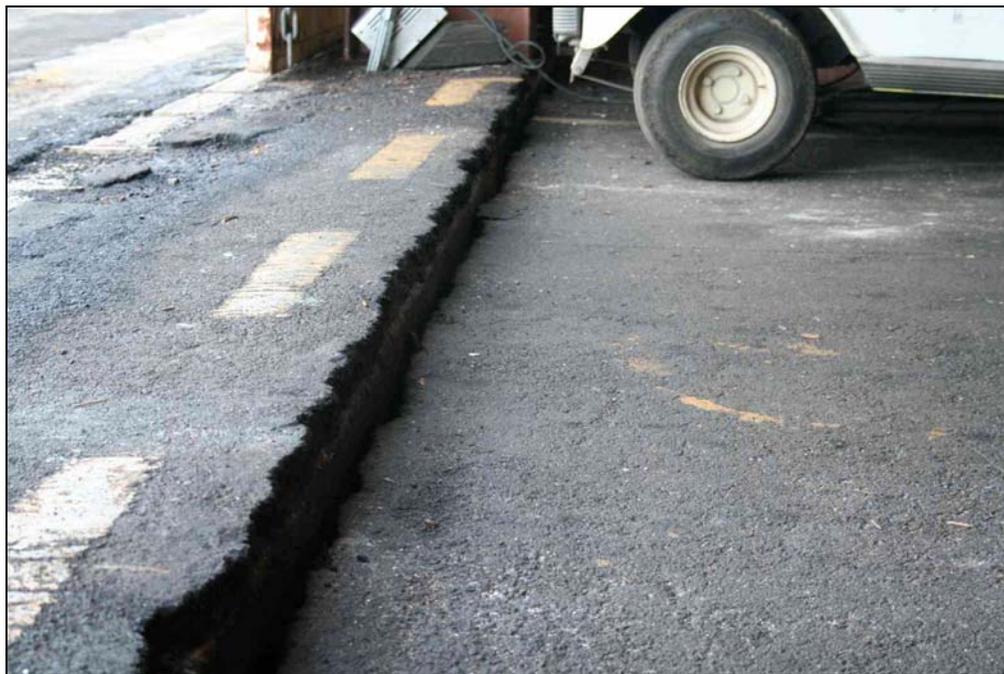
Figure 20 Liquefaction induced lateral and vertical displacements of approximately 6 inches at  
port facility, Kawaihae Harbor (Photograph by Peter Nicholson)

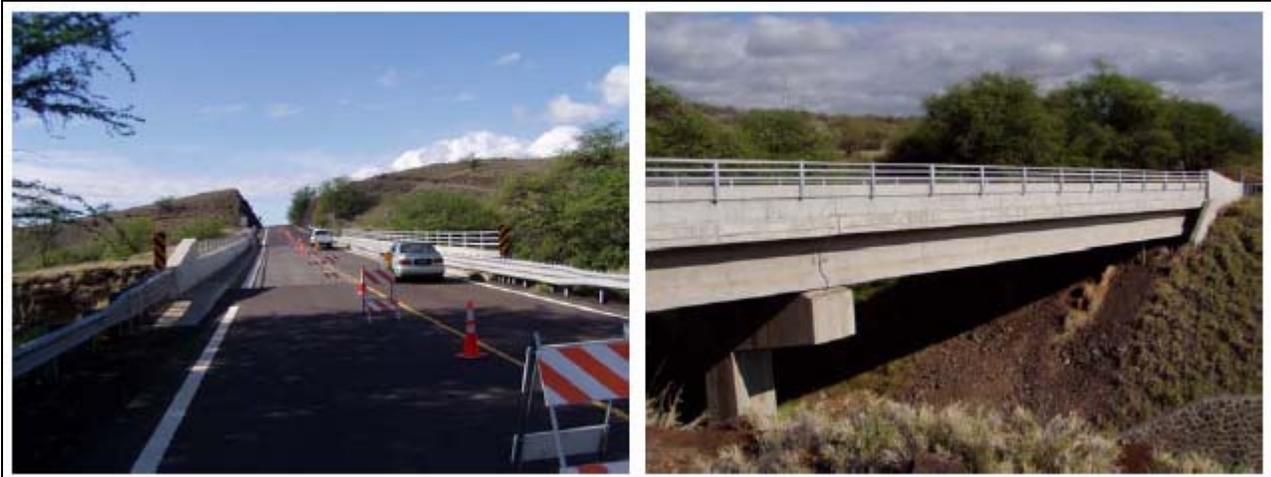
Figure 21 Honokoa Bridge (Photographs courtesy of Peter Nicholson)

The Honokoa bridge, built in 1965, is located just north of Kawaihae on the west coast of the Island of Hawai'i. It is within 24 km (15 miles) of both earthquake epicenters. The bridge consists of two spans of simply-supported AASHTO prestressed concrete bridge girders supporting a reinforced concrete bridge deck (Figure 21). Figure 22 shows a schematic of the bridge cross-section. Significant damage was noted to the webs of the AASHTO girders at the abutments (Figure 23). Evidence of relative movement and pounding between bridge segments and between the bridge deck and the abutments was apparent from spalling damage to the bridge guardrails.

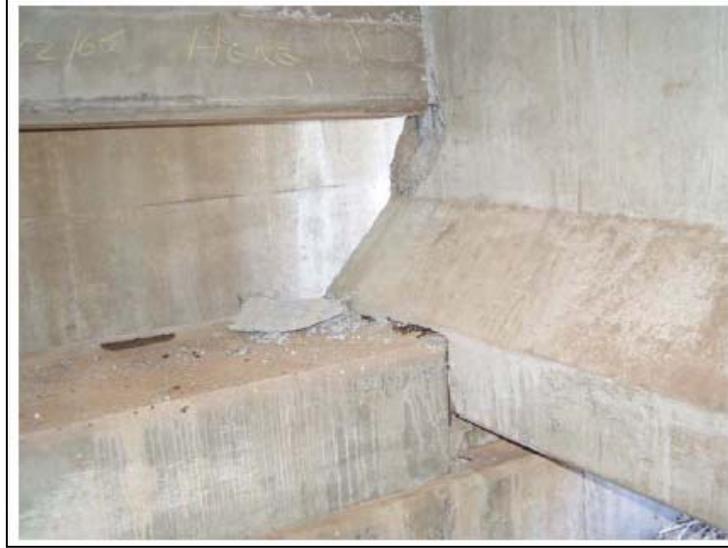
**Figure 23 Damage to web of AASHTO girder at Abutments  
(Photograph courtesy of Ian Robertson)**

It appears that the longitudinal motion of the bridge was effectively resisted by pounding against the abutments, while transverse motion was prevented by concrete shear keys between the bottom bulbs of the bridge girders. Unfortunately, the bulkhead or bridging beams at the supports were only partial depth (Figure 24) and did not extend to the bottom bulbs. Therefore, lateral restraint of the bridge deck had to transfer through the relatively thin girder webs, resulting in high transverse shear and flexural stresses for which the webs were not adequately designed. The bottom edge of the bridging beams showed a tendency to separate from the webs because of the large transverse inertial forces.

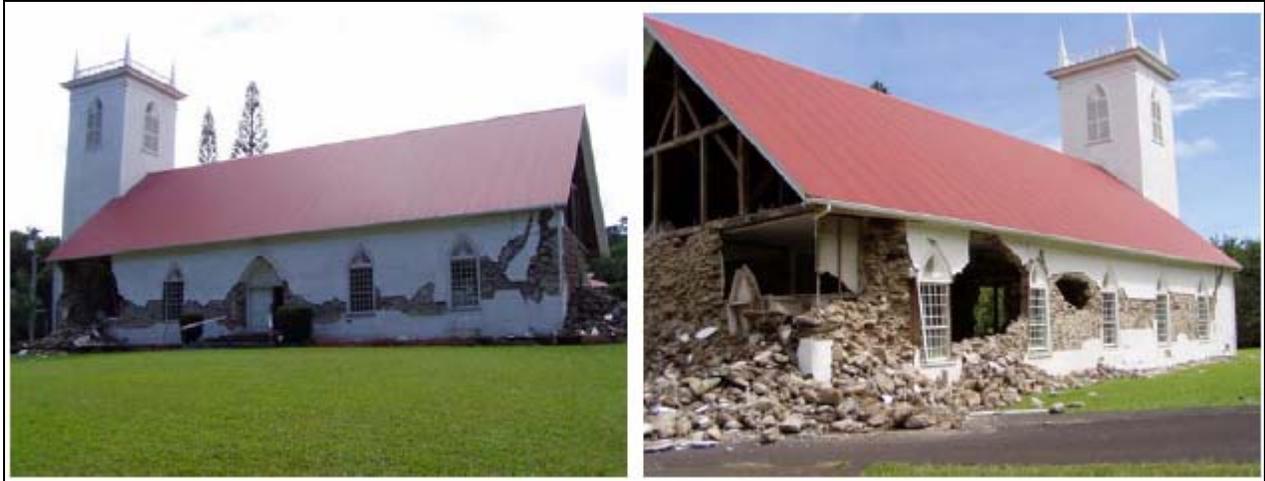
Figure 26 Kalahikiola Church in Hawi

The historic Kalahikiola Church in Hawi, North Kohala, suffered extensive damage to the exterior rock-masonry walls supporting the roof trusses (Figure 26). The end wall fell outward due to a lack of lateral restraint. The two side walls failed similarly but to a lesser degree; total collapse of the roof system appears to have been prevented by a single line of interior columns supporting the center of each roof truss and door and window frames supporting the eaves (Figure 27). The unreinforced rock-masonry walls were grouted with low-strength mortar, similar to many other rock-masonry walls built in the 19th and early 20th centuries (Figure 28). Many of these walls suffered damage in the form of cracking, partial collapse or complete collapse. The other end of the building (where the pastor would preach) is constructed with a wood end wall and wood tower. This end of the building appeared unscathed. The timber-framed bell tower appeared to have survived the earthquake with limited damage. Estimates are as high as \$3 million to rebuild the Kalahikiola Congregational Church.

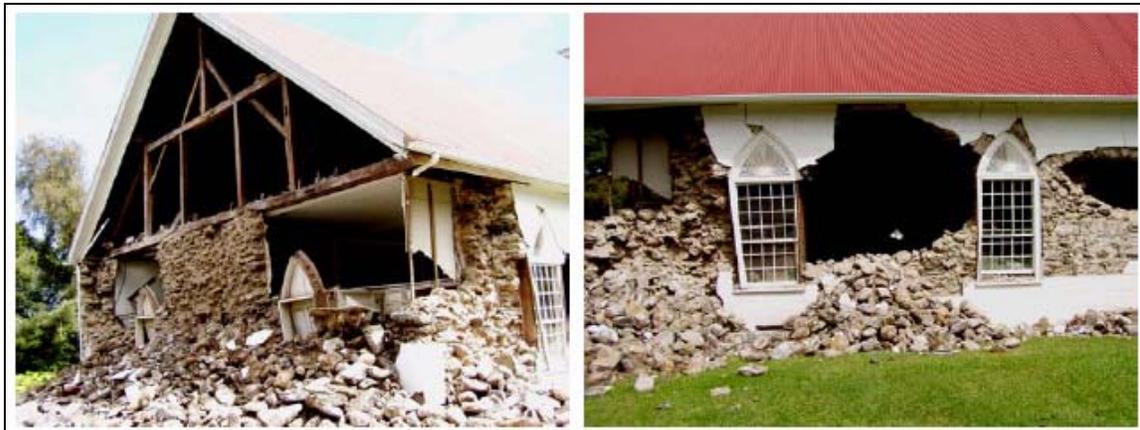
Figure 27 Roof trusses supported by interior columns and window frames after wall collapse . (Photographs courtesy of Ian Robertson)

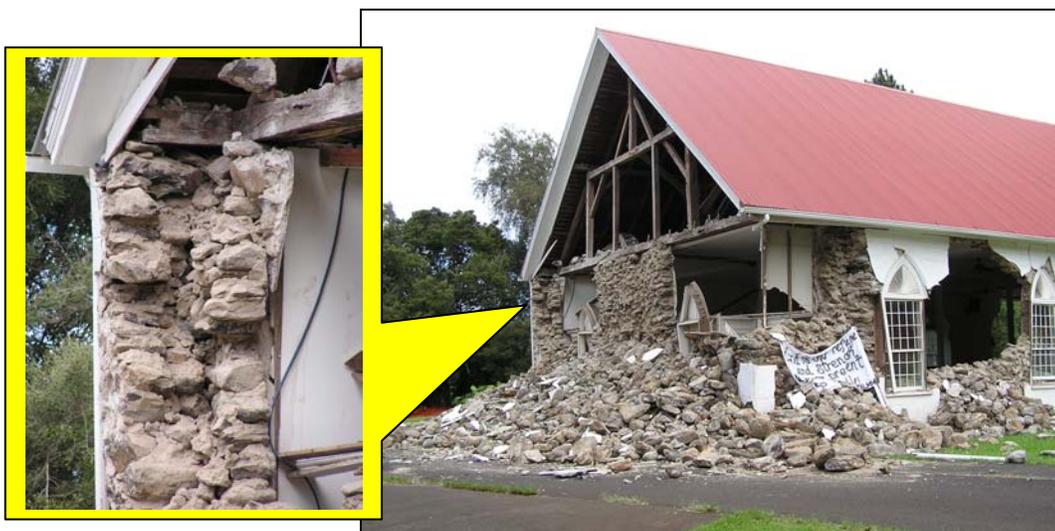
Figure 28 Unreinforced basalt rock-masonry walls filled with low strength mortar and smaller rubble (Photograph courtesy of Edward Medley)

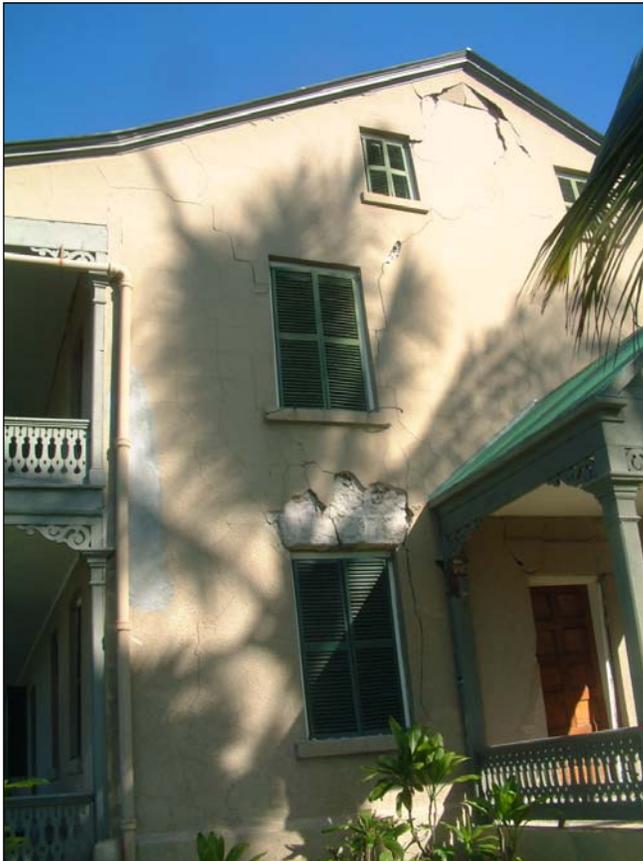
The Palace suffered extensive damage and was at one point deemed unfit for occupancy. Typical diagonal cracking occurred in the cementitious plastered masonry exterior walls of the building, particularly around door and window openings (Figure 29). Hulihe'e Palace was reopened after consultants to the Department of Land and Natural Resources indicated that the damage was not to the extent of earlier concerns that it was not structurally sound. Although the building had initially been "red-tagged" by inspectors in the week after the earthquake, the hazard designation was later changed to a yellow tag. Access to the public was limited to the center room at the first floor and the oceanfront first floor lanai. Access to the other rooms in the Palace were restricted to staff and workmen. There is an extensive amount of damage to interior finishes and separation gaps in the floors and ceilings. Estimated repair cost was stated to be approximately \$1 million.

**Figure 29 Damage to the plaster finish and masonry of a gable end wall of Hulihe'e Palace**

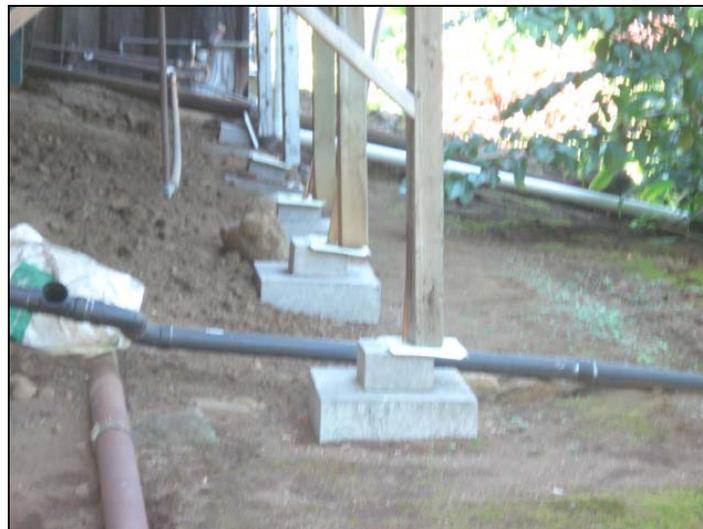
Figure 31 Tall unanchored posts on the verge of slipping off their foundation piers; note splitting of wood columns at their bases (Photograph courtesy of Kylie Yamatsuka)

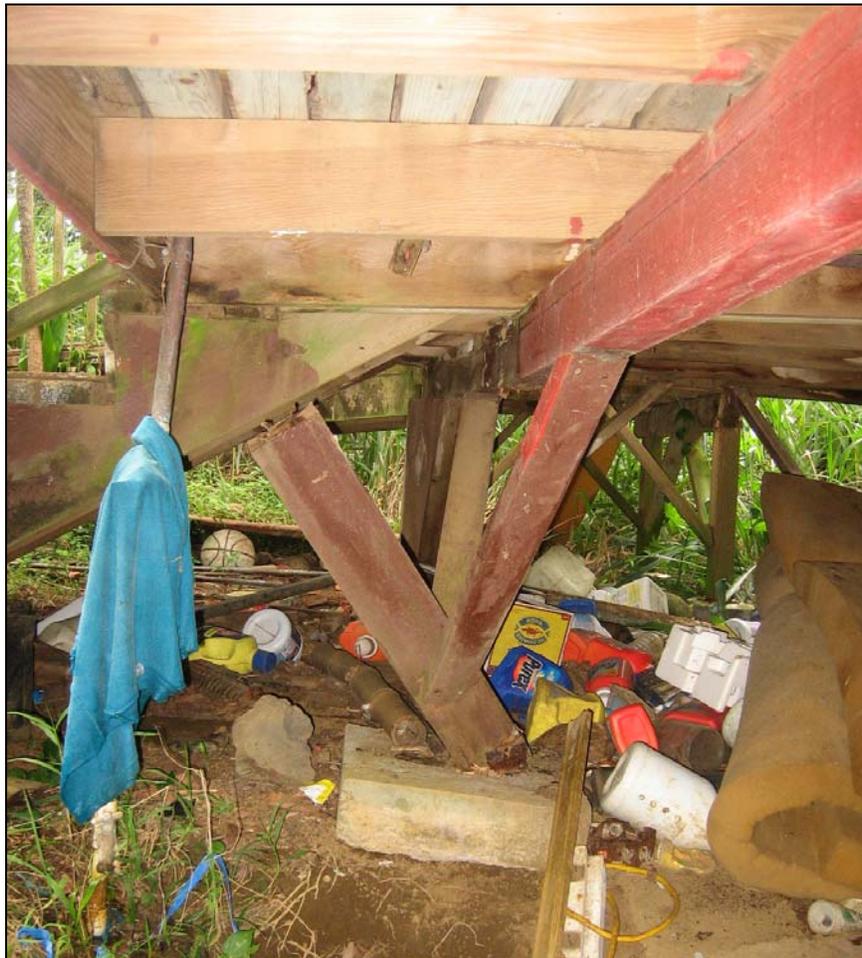
**Figure 32 Detachment of a Post at the Top and Bottom at a Sloping Hillside Site  
(Photograph courtesy of Tim Waite)**

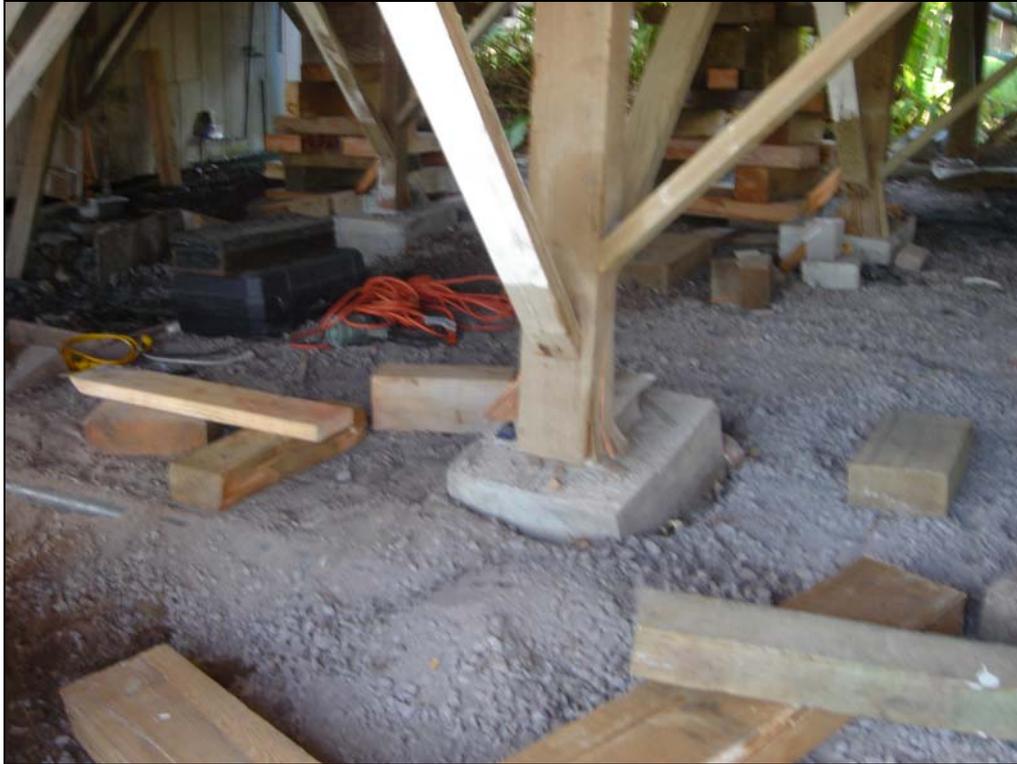
**Figure 33 Splitting of a Post Base with Lateral Displacement**  
(Photograph courtesy of Ron Iwamoto)

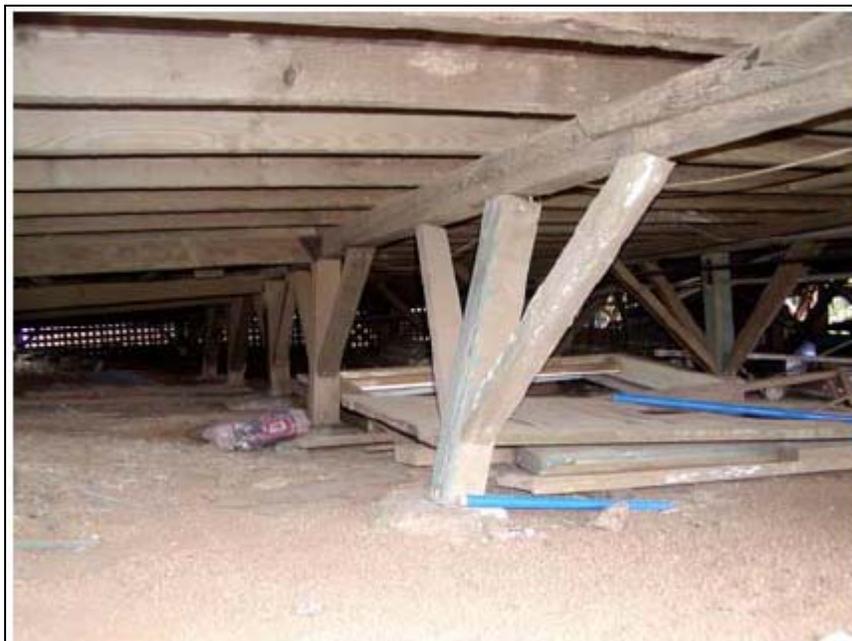
**Figure 34 Rotational Instability Mode of Post and Pier “Single” Wall Homes**  
(Photograph courtesy of Ian Robertson)

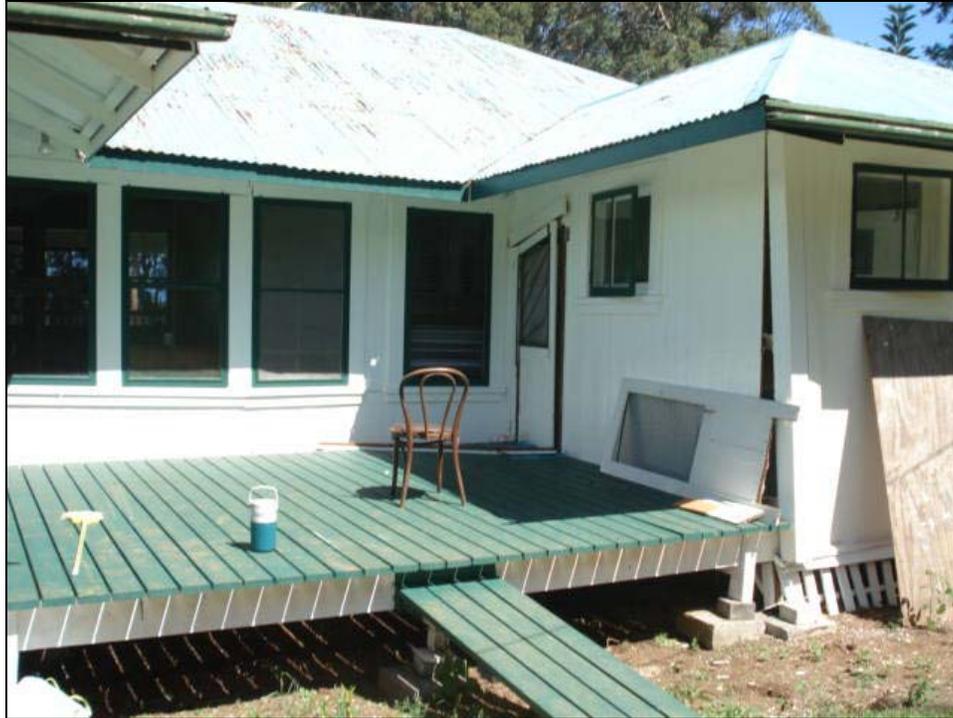
Figure 35 Major damage to a light-wood-framed “single” wall home after collapse of a portion of the post and pier system (Photograph courtesy of Kylie Yamatsuka)

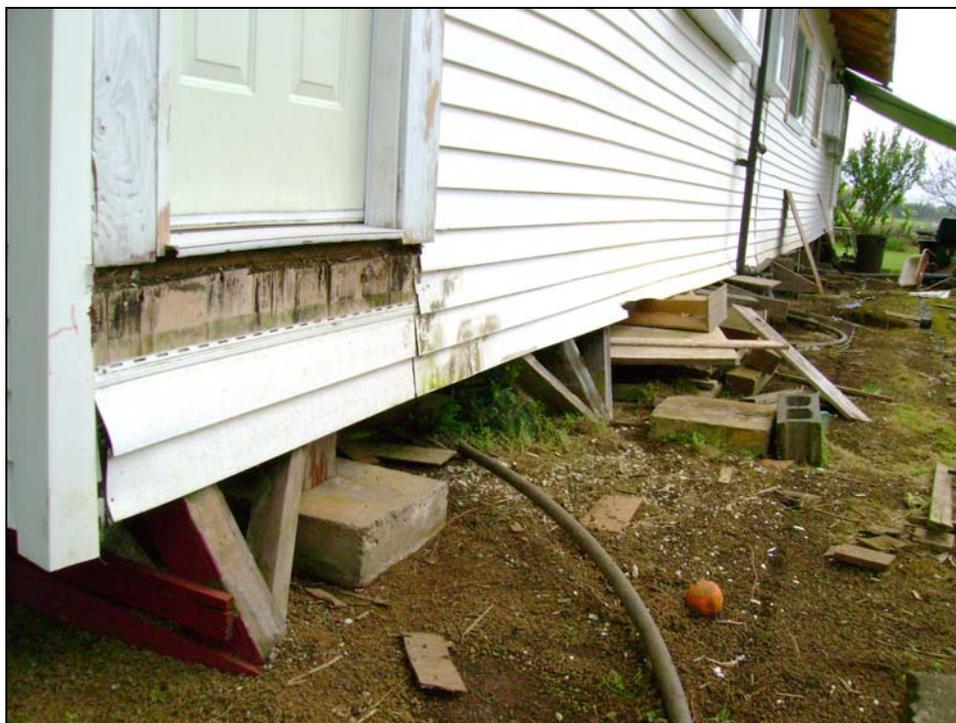
Figure 36 Collapse of the Post and Piers of a Single Wall Home; note lateral displacement from footing (Photograph courtesy of Clifford Lau)

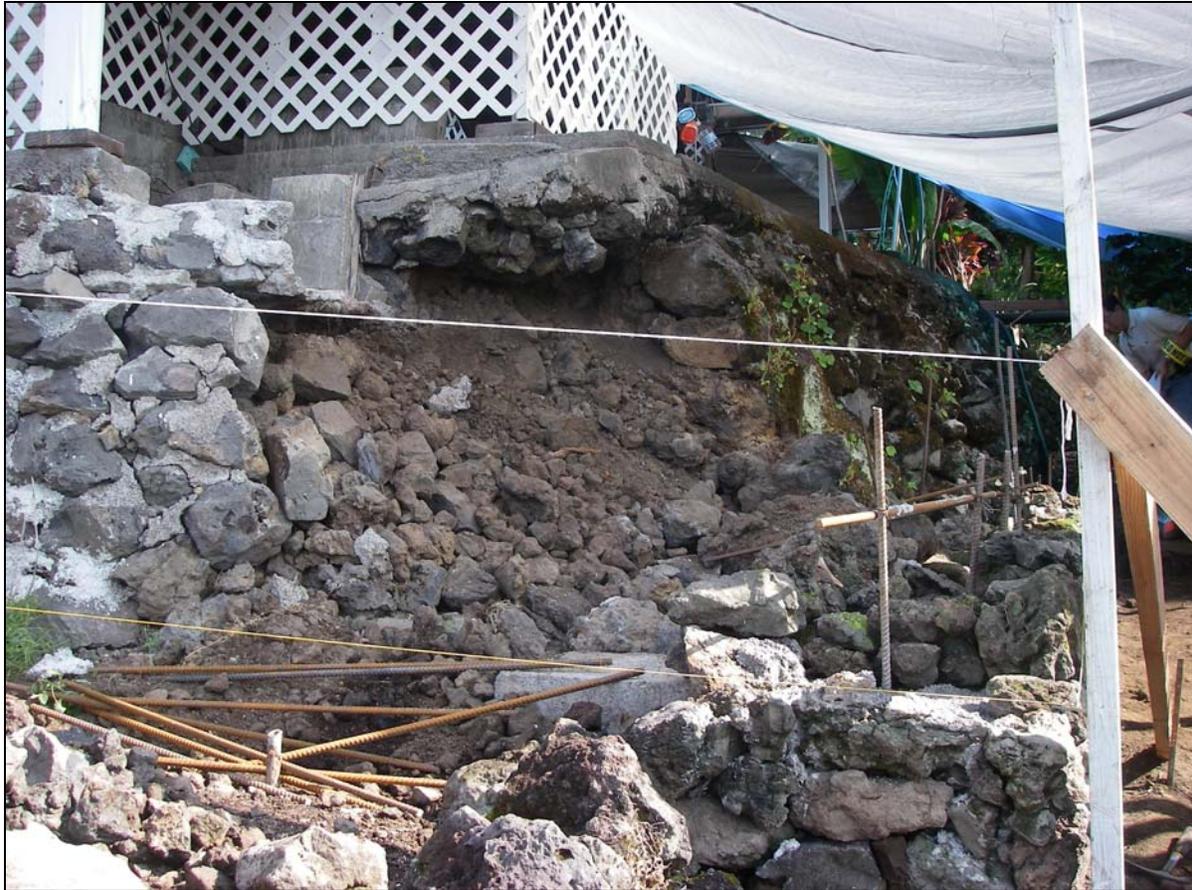
Many residences experienced damage to lava rock retaining walls. These walls typically consisted of individual, rough lava rocks stacked dry, or with minimal mortar (Figure 38). The walls were commonly 3 to 5 feet in height, although in some cases taller. In the County of Hawaii, the building code allows walls of up to six feet to be constructed without engineering drawings. Many minimally mortared rock walls failed during the earthquake. Numerous dry-stacked rock walls crumbled in the earthquake (Figures 39 and 40).

**Figure 38** Failure of a loosely fitted and mortared lava rock wall causing undermining of single family home; note the beginning of a replacement wall construction in foreground (Photograph courtesy of Glenn Miyasato)

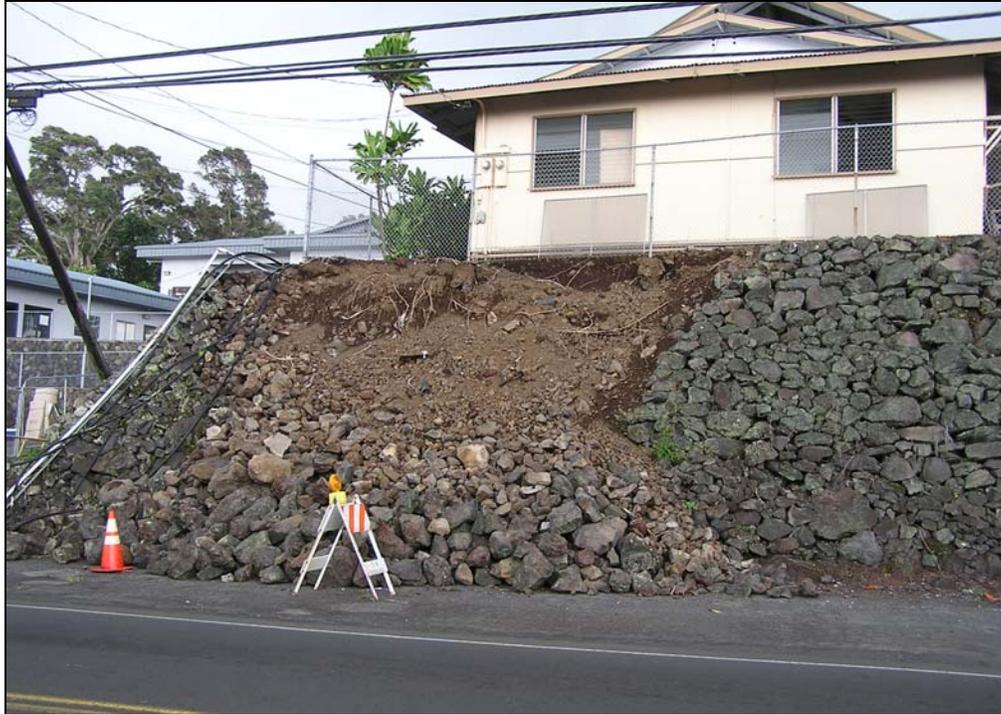
Figure 39 Failed stacked rock retaining wall in Captain Cook, adjacent Hwy 11.  
(Photograph courtesy of Edward Medley)

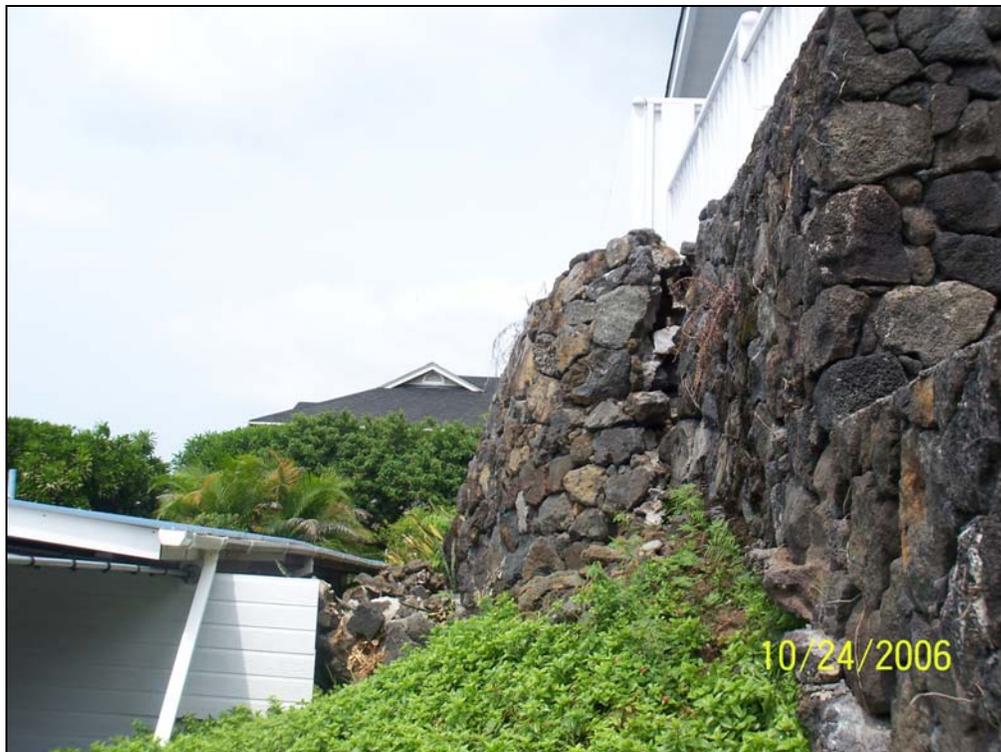
Figure 40 Failure of a dry-stacked lava rock wall threatening a neighboring property (also note damaged carport) (Photograph courtesy of Lee Takushi)

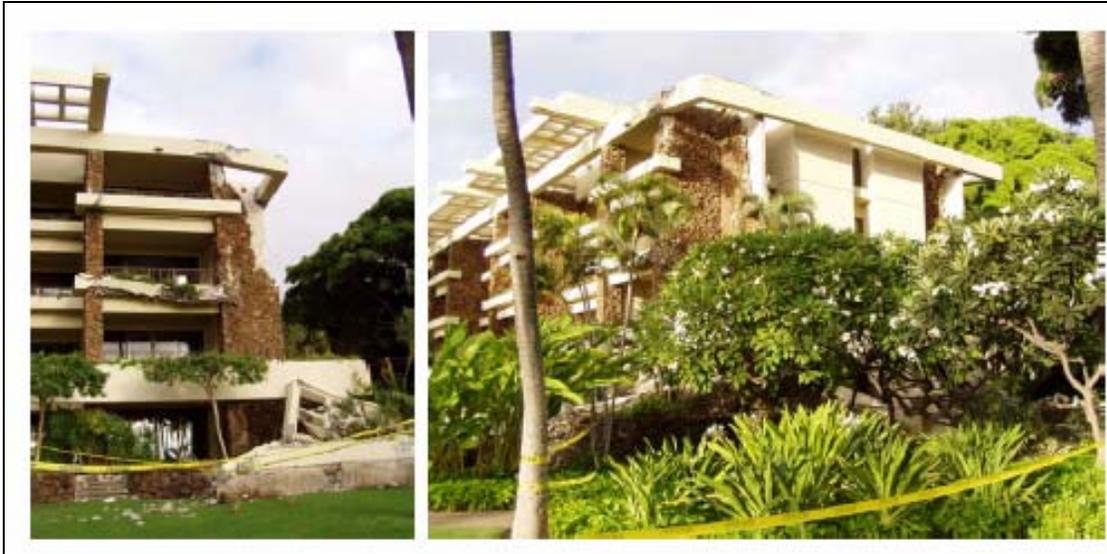
**Figure 42 Collapse of concrete trellis frame at Mauna Kea Beach Hotel.  
(Photograph courtesy of Ian Robertson)**

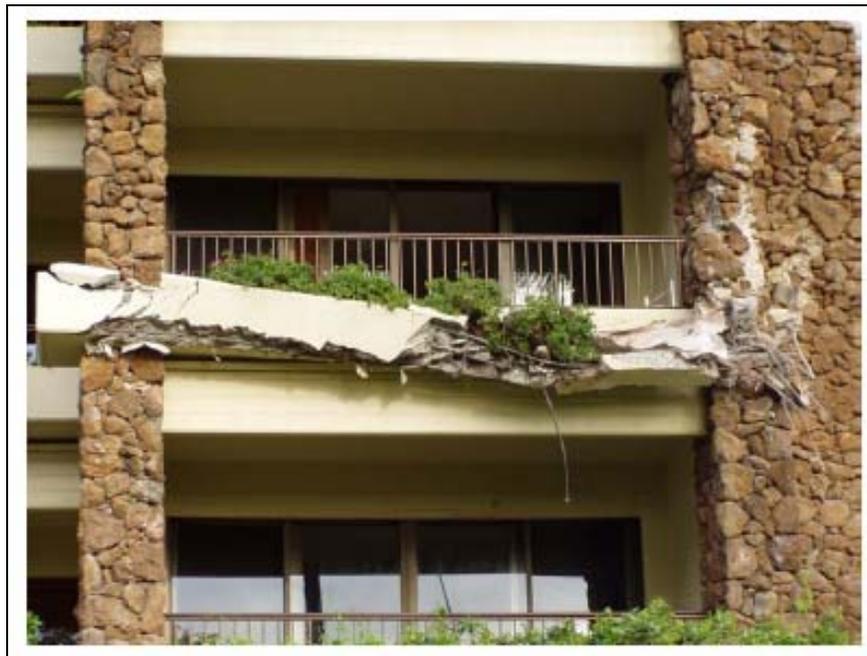
**Figure 43 Damage to balcony due to impact from falling debris  
(Photograph courtesy of Ian Robertson)**

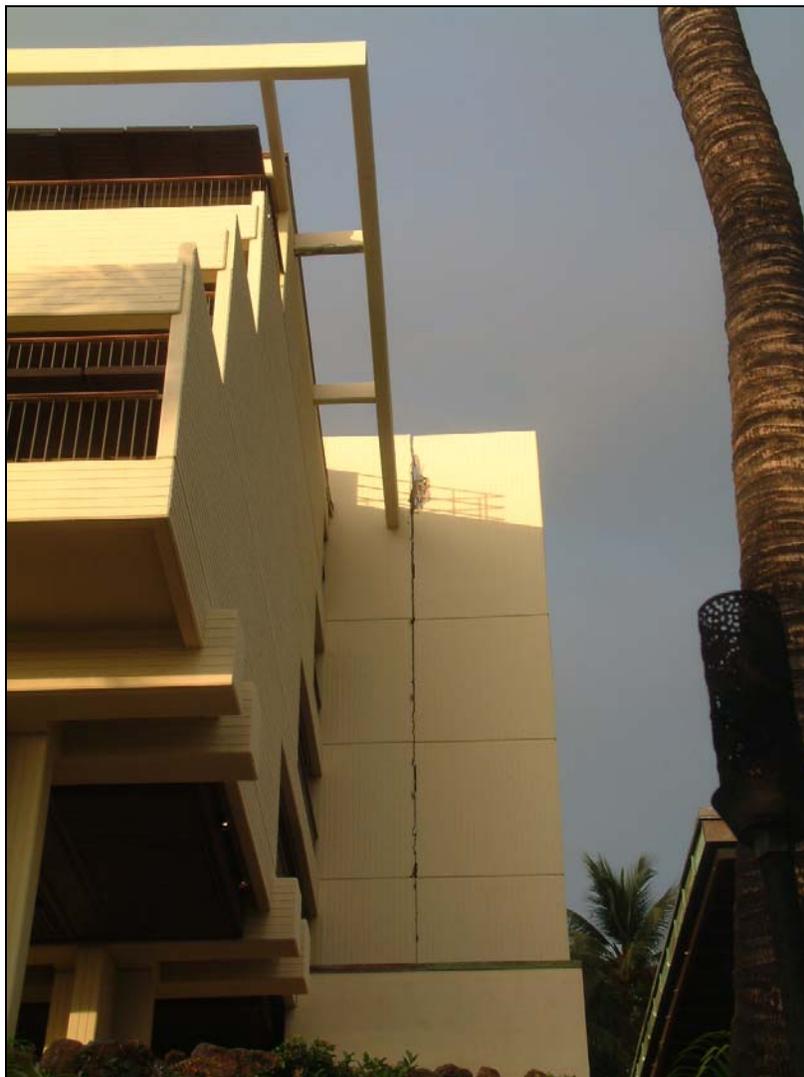
**Figure 44 Damage to concrete exhaust flume at connector plate – west side.  
(Photograph by Gary Chock)**
