# Compilation of Observations of the October 15, 2006 Kiholo Bay (Mw 6.7) and Mahukona (Mw 6.0) Earthquakes, Hawai'i

December 31, 2006

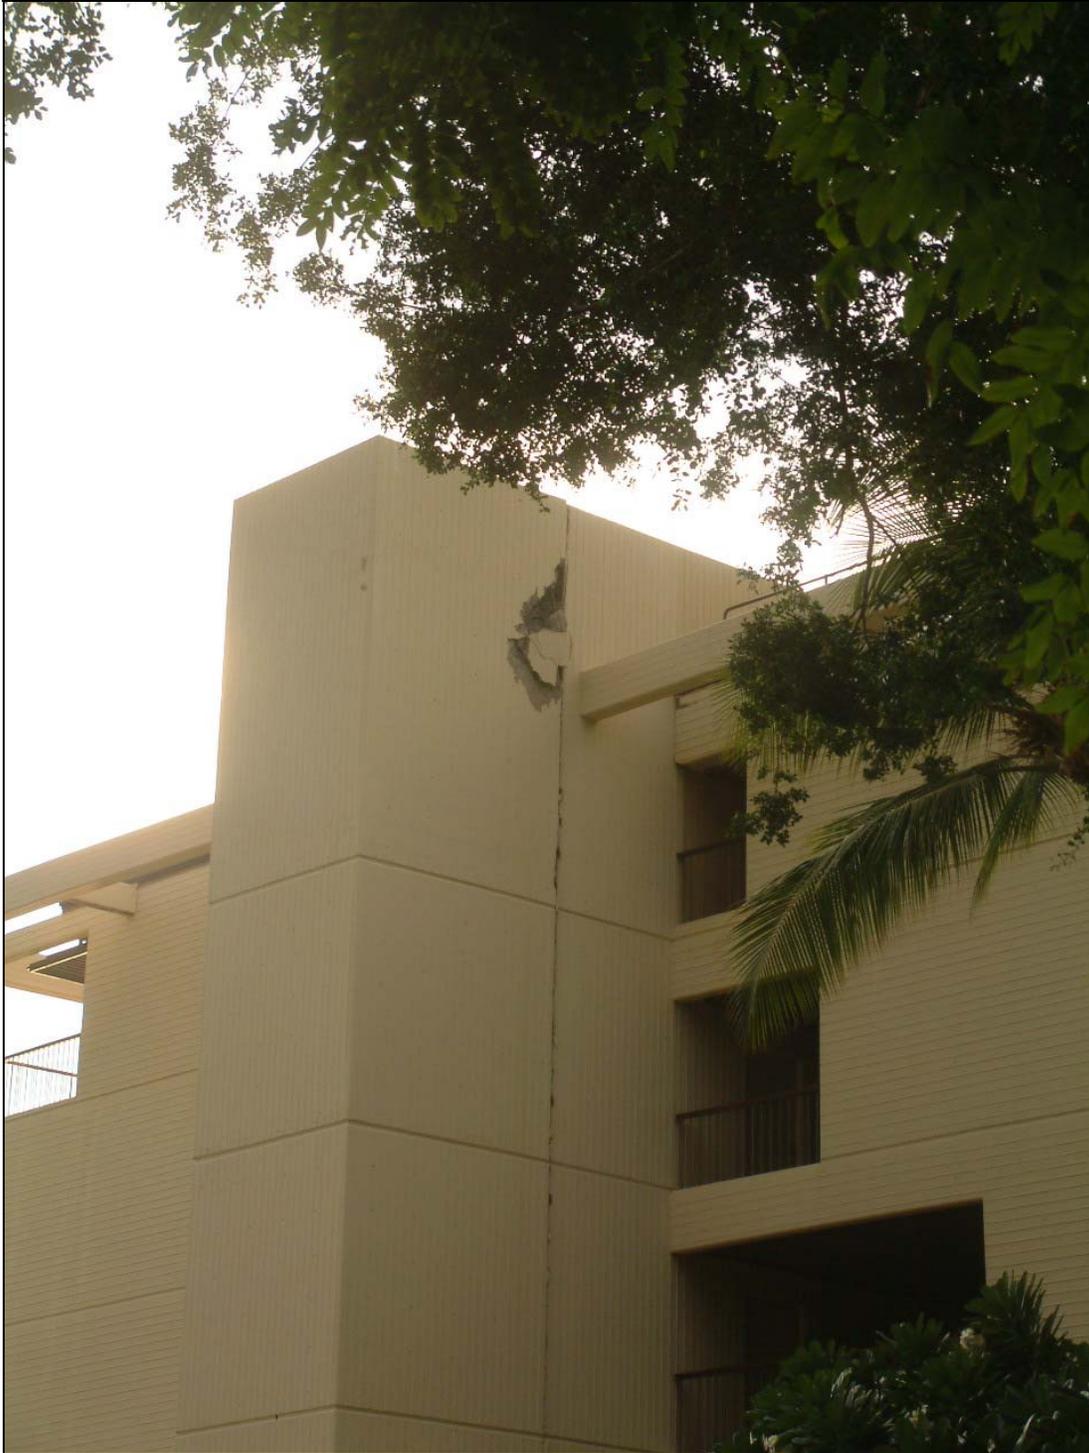
**Figure 45** Damage to concrete exhaust flume at connector plate – east side.  
(Photograph by Gary Chock)

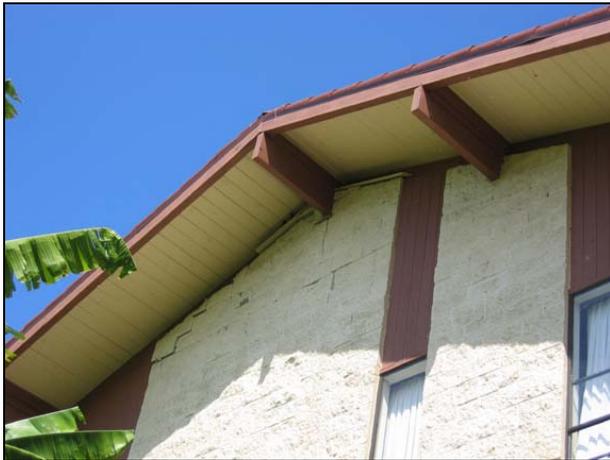
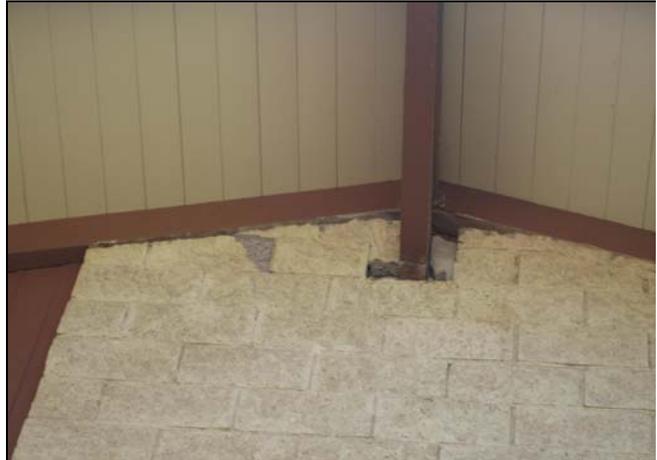
Figure 47 Out-of Plane Shear failures at the gable end CMU walls, Paniolo Club, Waikoloa Village  
(Photographs courtesy of Jeffrey Hanyu)

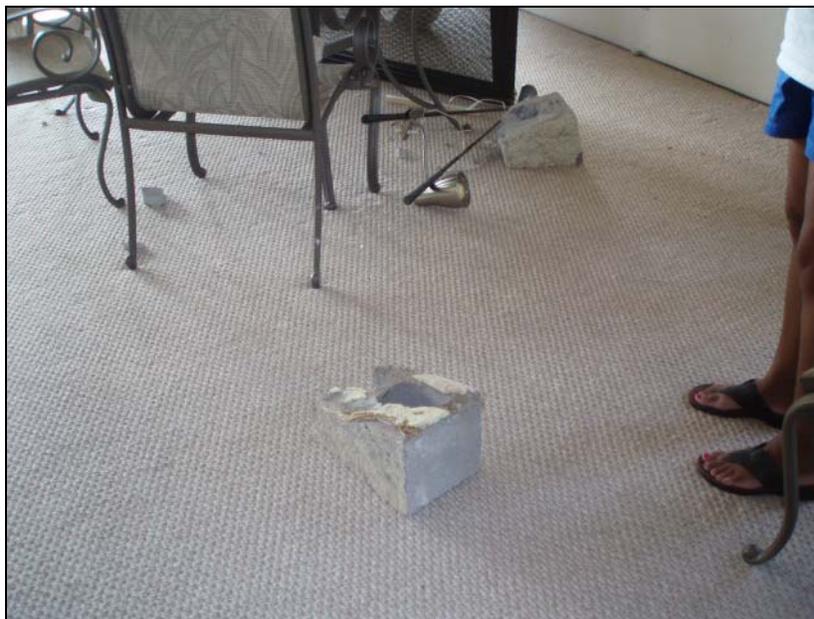
Figure 48 Dislodged CMU falling debris, Paniolo Club, Waikoloa Village  
(Photo courtesy of Mike Kasamoto)

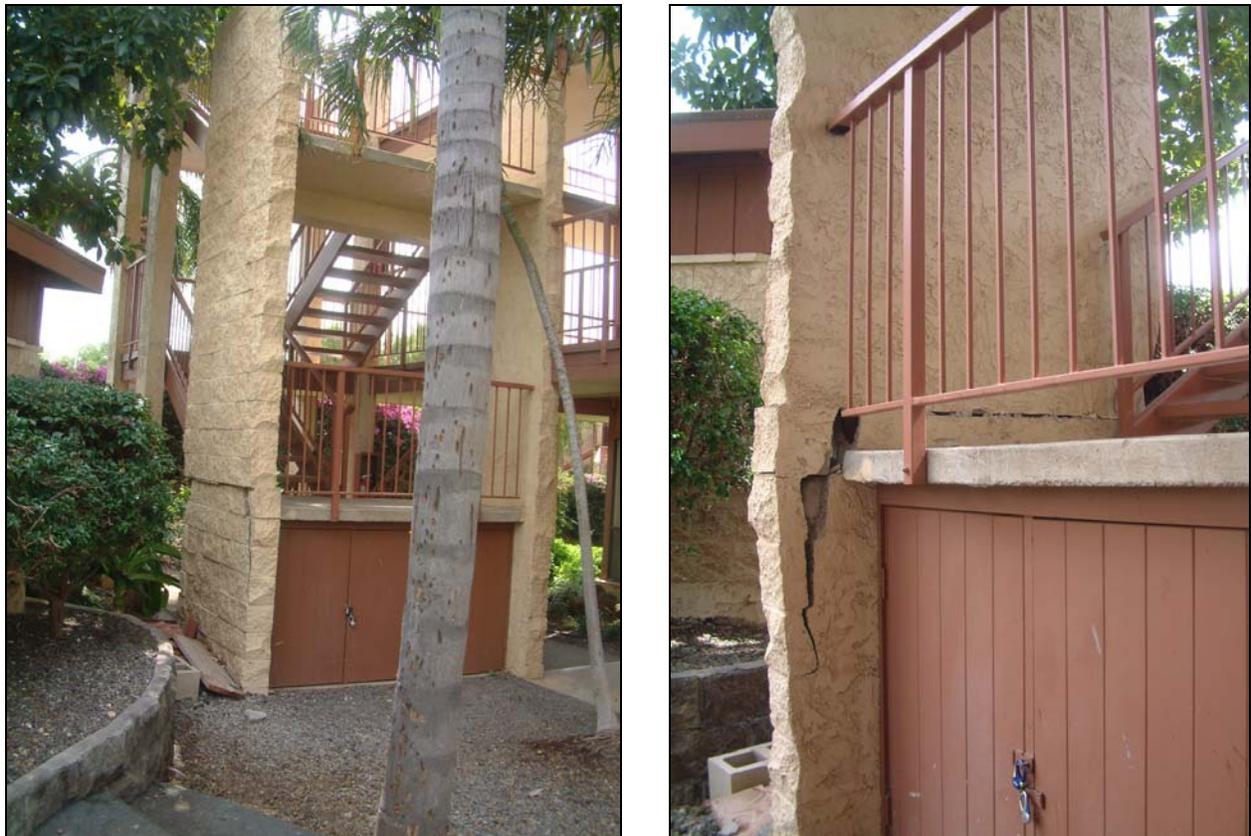
**Figure 49 Exit Stair Support Wall with Spalled End Cells  
and Lateral Displacement In-Plane and Out-of-Plane  
(Photograph by Gary Chock)**

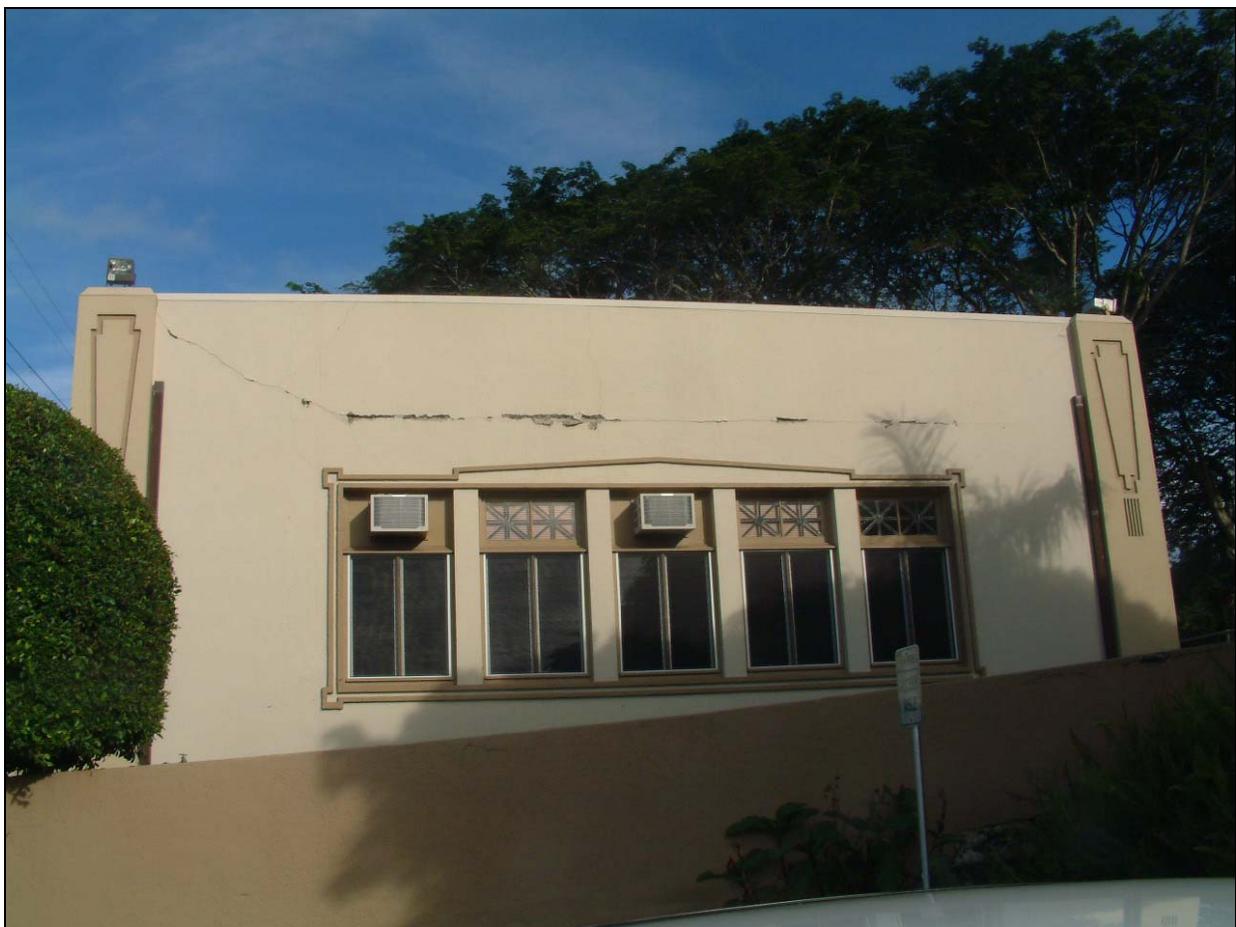
**Figure 50 Horizontal and diagonal cracks in concrete walls  
of Bank of Hawaii in Kapaau, near Hawi  
(Photograph by Gary Chock)**

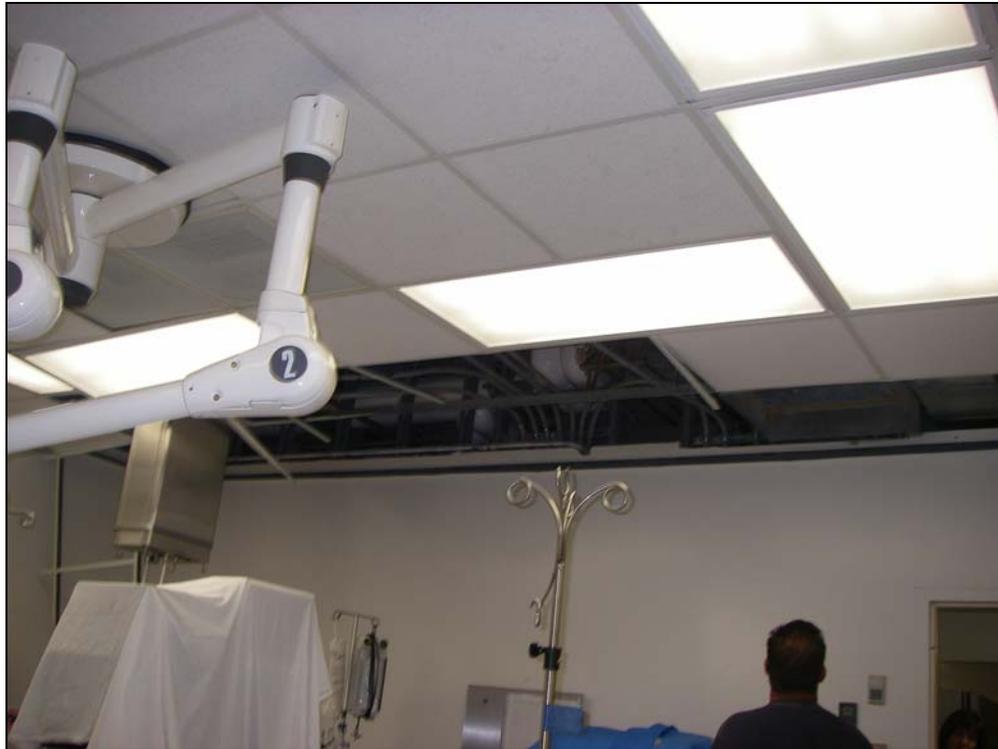
**Figure 51** Fallen Ceiling in the Operating Room, Kona Community Hospital  
(Photograph courtesy of Glenn Miyasato)

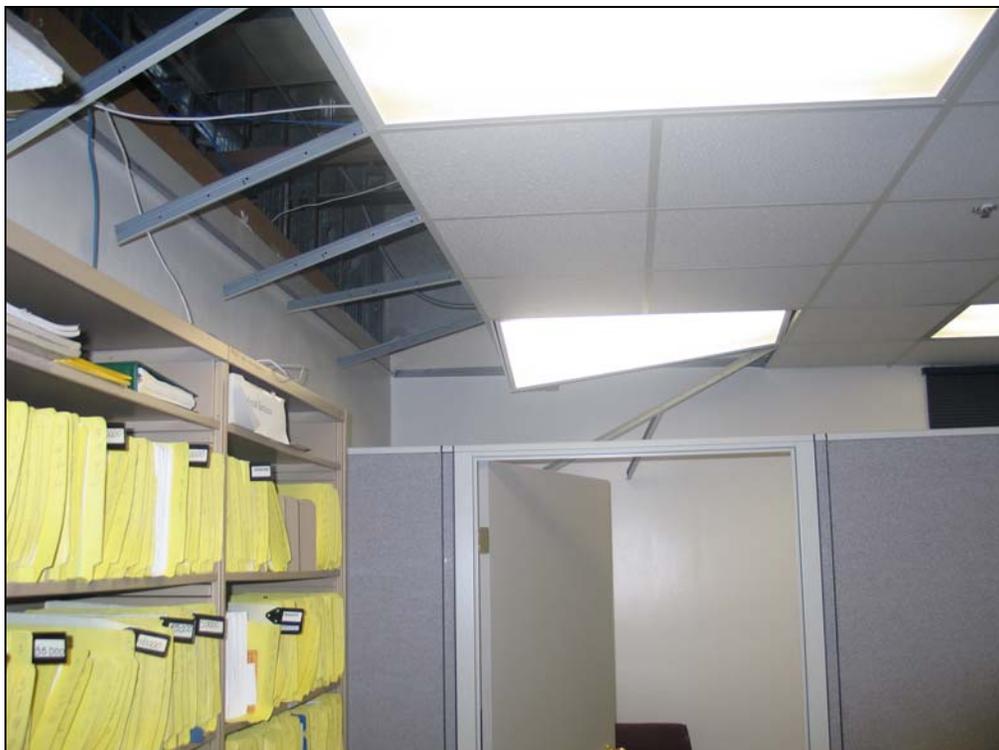
**Figure 52** Ceiling Damage in a Medical Records Room at Kona Community Hospital  
(Photograph courtesy of William Holmes)

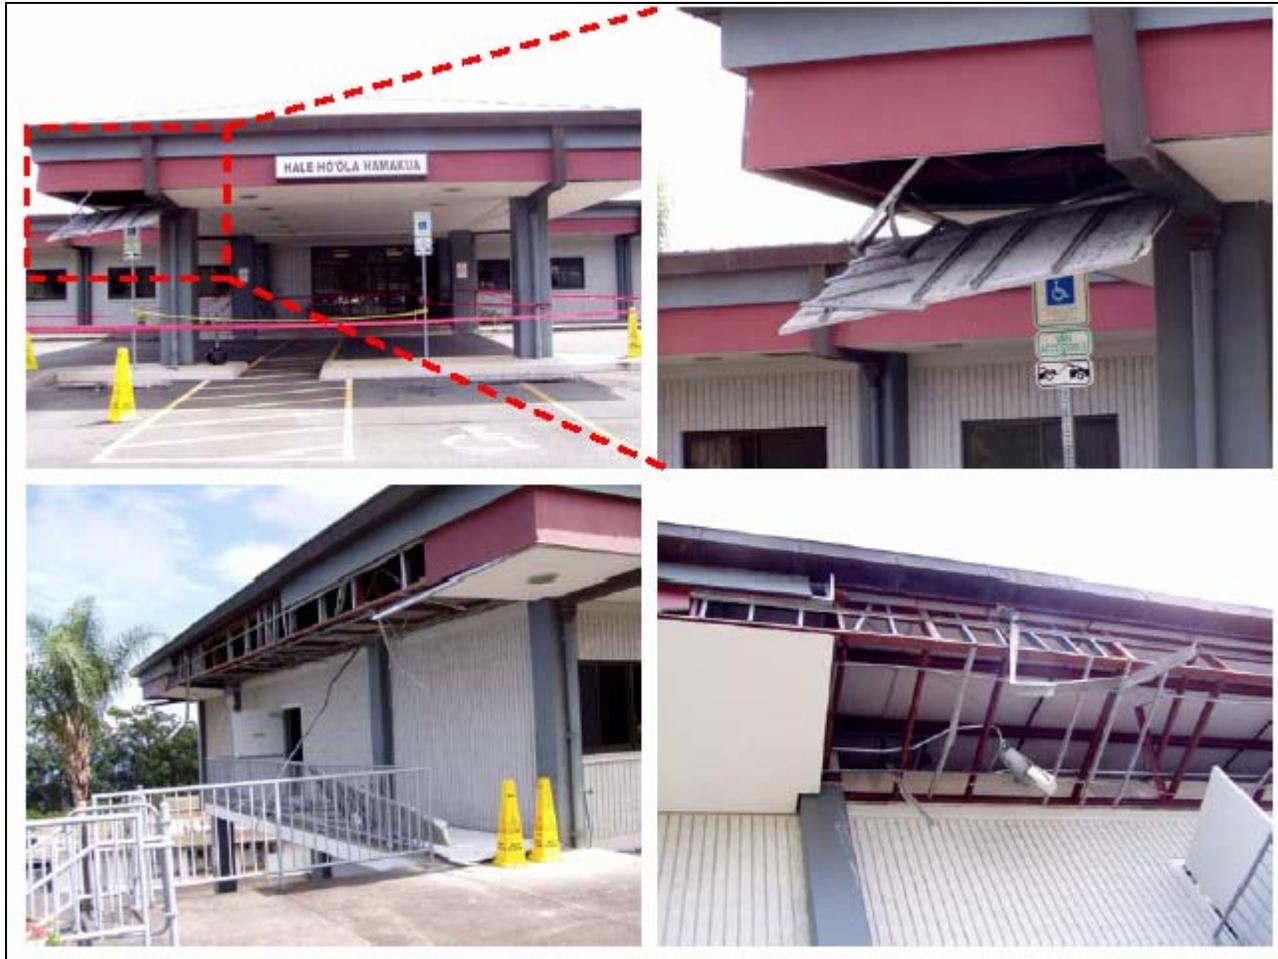
Figure 53 Damage to exterior stucco ceilings at Hale Ho'ola Hamakua medical facility in Honoka'a  
(Photographs courtesy of Ian Robertson)
