# Compilation of Observations of the October 15, 2006 Kiholo Bay (Mw 6.7) and Mahukona (Mw 6.0) Earthquakes, Hawai'i

December 31, 2006

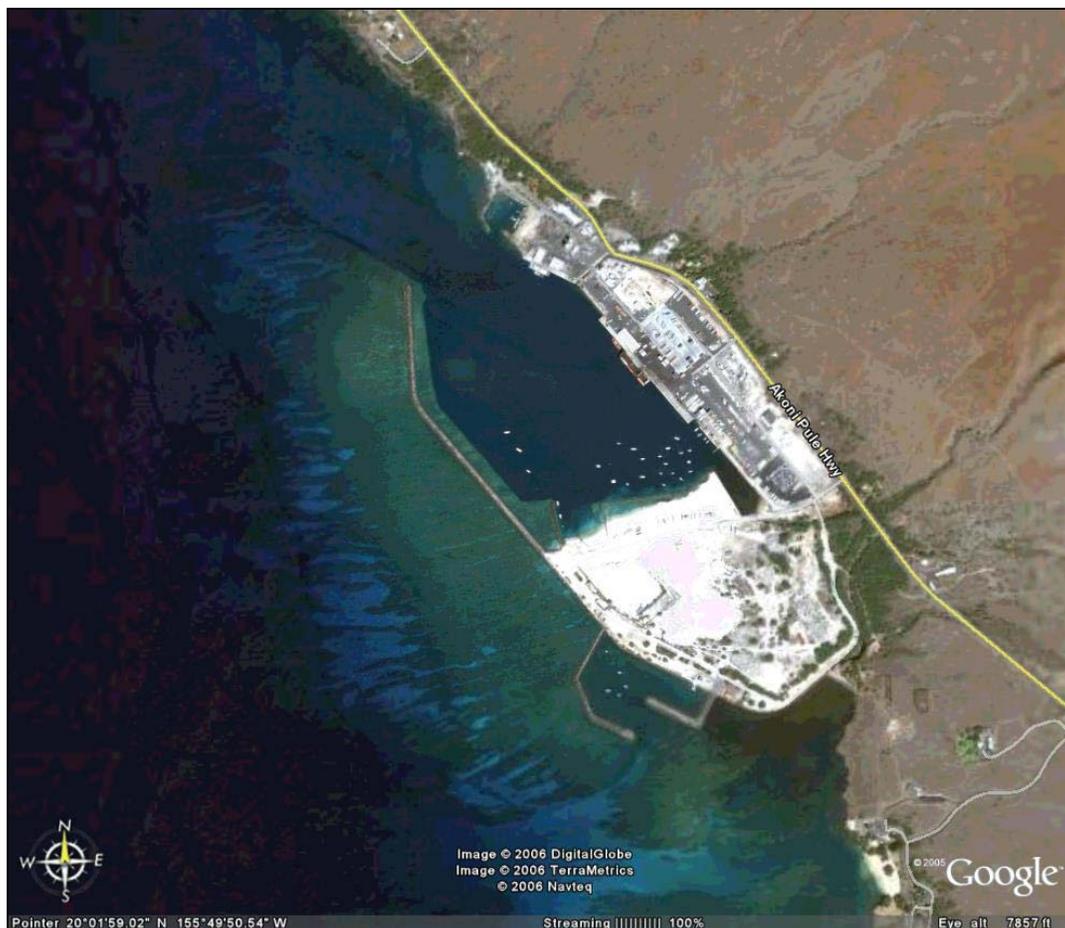
**Figure 18 Kawaihae Harbor**

One of the two major commercial ports on the island, the commercial port facility at Kawaihae Harbor consists of two pile-supported concrete piers, a 500-foot long Pier 1 and the 1500-foot long Pier 2, which is operationally divided into Piers 2, 2A and 2B and a few warehouse and administrative buildings, and an asphalt paved shipping container yard (Figure 18). This facility is located less than 24 km (15 miles) from both earthquake epicenters.

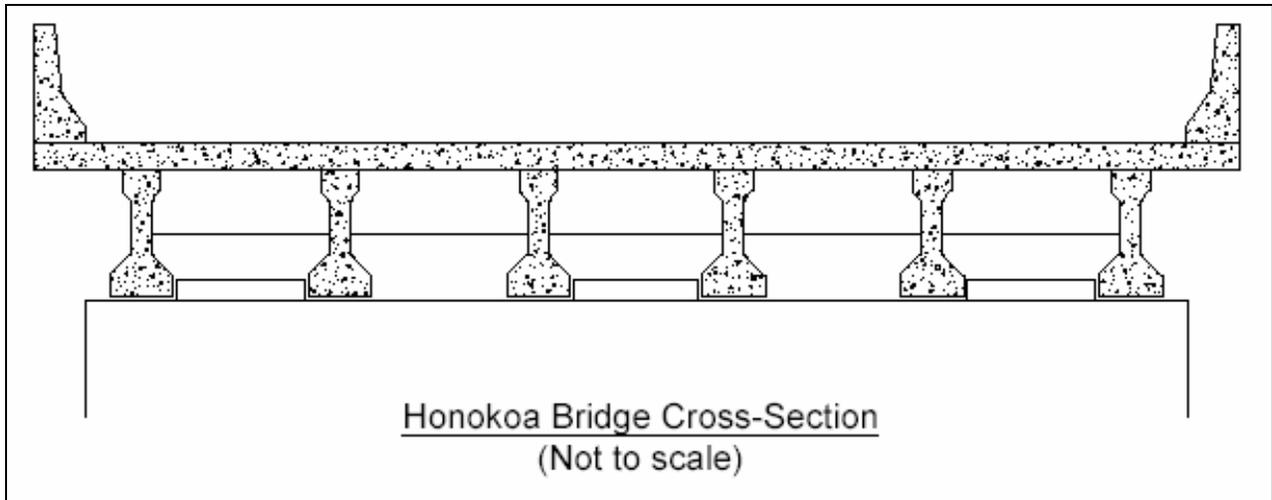
Figure 22 Cross-section through Honokoa Bridge. (Diagram by Ian Robertson)

The Honokoa bridge, built in 1965, is located just north of Kawaihae on the west coast of the Island of Hawai'i. It is within 24 km (15 miles) of both earthquake epicenters. The bridge consists of two spans of simply-supported AASHTO prestressed concrete bridge girders supporting a reinforced concrete bridge deck (Figure 21). Figure 22 shows a schematic of the bridge cross-section. Significant damage was noted to the webs of the AASHTO girders at the abutments (Figure 23). Evidence of relative movement and pounding between bridge segments and between the bridge deck and the abutments was apparent from spalling damage to the bridge guardrails.

This bridge was scheduled for a seismic retrofit which was to include extending the bulkhead to the bottom of the girders. This retrofit had already been performed on three similar bridges on the Island of Hawaii, none of which experienced damage during the earthquakes.

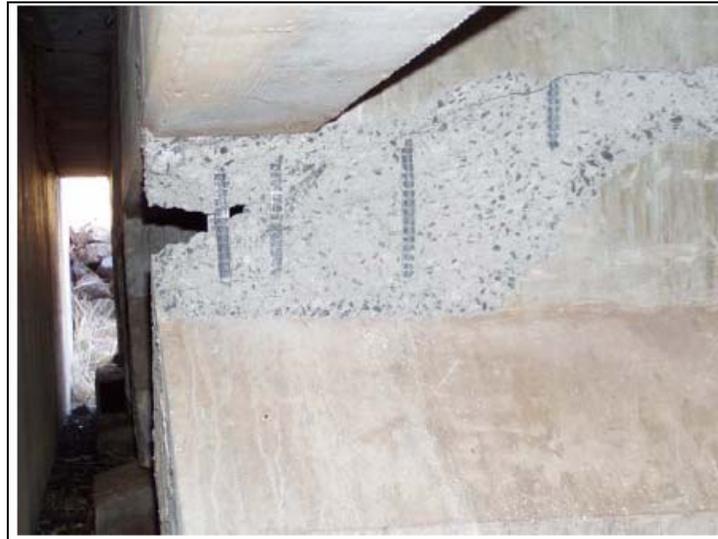
It appears that the longitudinal motion of the bridge was effectively resisted by pounding against the abutments, while transverse motion was prevented by concrete shear keys between the bottom bulbs of the bridge girders. Unfortunately, the bulkhead or bridging beams at the supports were only partial depth (Figure 24) and did not extend to the bottom bulbs. Therefore, lateral restraint of the bridge deck had to transfer through the relatively thin girder webs, resulting in high transverse shear and flexural stresses for which the webs were not adequately designed. The bottom edge of the bridging beams showed a tendency to separate from the webs because of the large transverse inertial forces.

**Figure 24 Shear key and bridging beam between AASHTO bridge girders  
(Photograph courtesy of Ian Robertson)**

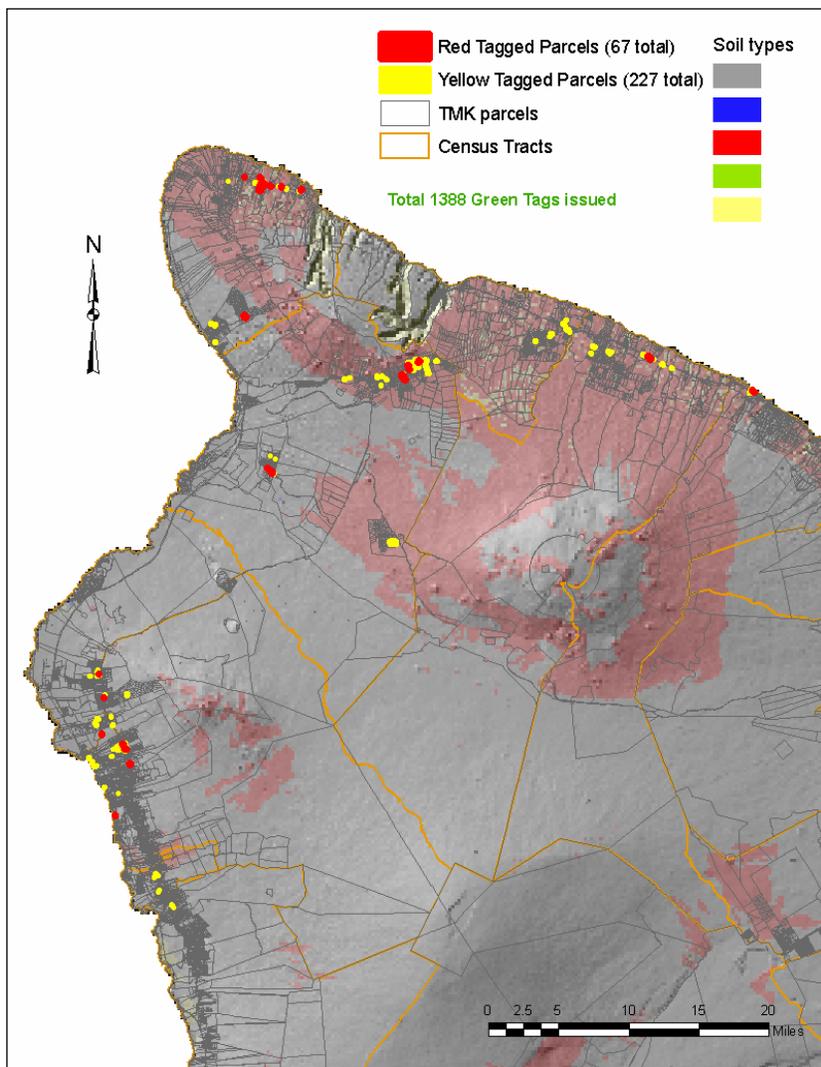
A county database was used to initiate American Red Cross visits to the occupants of all red and yellow tagged homes. The local utility company, HELCO, also disconnected electrical service to the red-tagged homes. The County of Hawaii also announced that owners of yellow and red-tagged homes are allowed to submit their repair plans to the Building Division for review without paying any processing fees. About 70 homes were red-tagged, and 230 were yellow-tagged based on potentially hazardous conditions, out of a total of approximately 1,700 inspections as of a month after the event. This number does not include more than 10 homes destroyed outright. Figure 25 maps the spatial distribution of moderate to severe damage to these homes, suggesting the significance of soil amplification of ground motion.

**Figure 25 Red- and yellow-tagged homes overlaid on soil type**

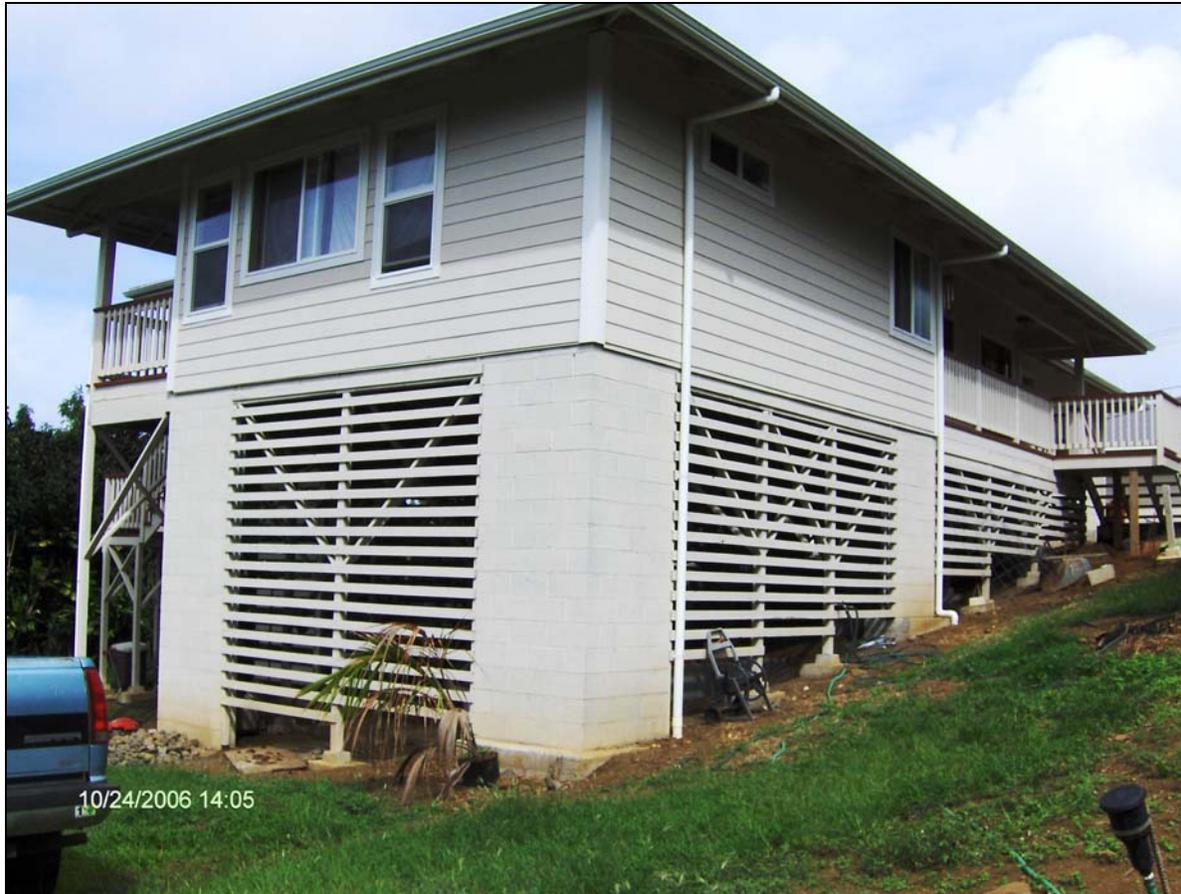
In more recent construction, some designs make use of corner L-shaped walls of reinforced CMU following 1997 recommendations of the Structural Engineers Association of Hawaii and Hawaii State Civil Defense (Figure 37).

**Figure 37 An example of an undamaged home with an improved form of elevated floor framing on a hillside utilizing masonry corner walls (Photograph courtesy of Gary Suzuki)**

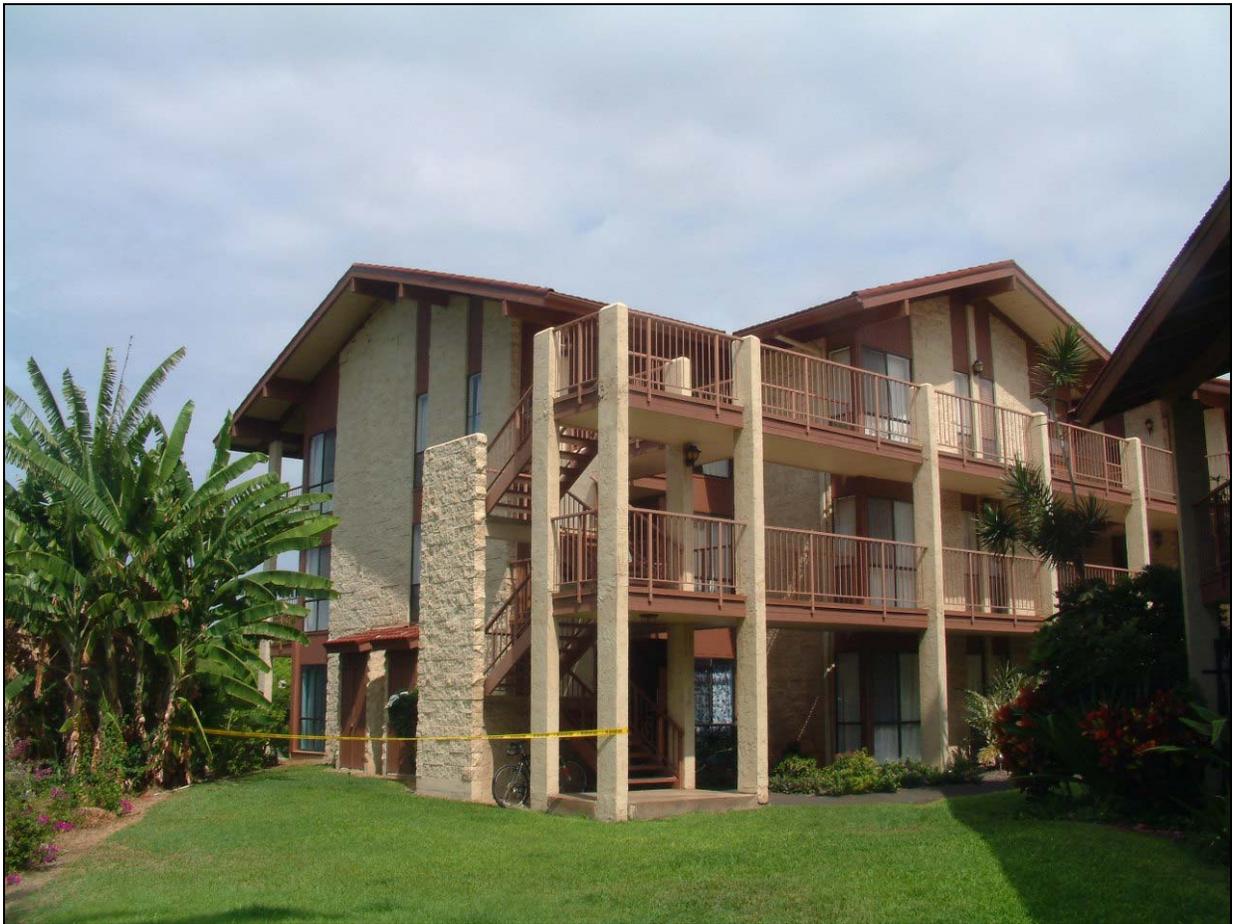
The Paniolo Club condominiums are a cluster of several two-story and three-story buildings built in the mid-1970's. The framing system is comprised of load-bearing concrete masonry unit walls and wood-framed floors and roofs. The exitways and stairs are on the exterior, supported by masonry piers. The masonry walls were partially grouted. The roof is configured with gable ends where the main roof beams and rim rafters bear on angled masonry walls. The roofing consisted of concrete tiles on straight sheathed wood decking (Figure 46).

**Figure 46 Typical Paniolo Club Condominium Three-Story Building, Waikoloa Village  
(Photograph by Gary Chock)**

A number of localized but severe areas of damage occurred. The CMU at the tops of the gable-ended masonry walls suffered out-of-plane dislodgements, particularly at the roof beam pockets (Figure 47). In some cases portions of the wall fell out onto the grounds or onto the floor of the units. Many of these masonry units were found to be ungrouted and unreinforced (Figure 48). The most severely damaged buildings were red-tagged as unsafe due to the potential collapse hazard of the bearing walls and roof.
